Access Compliance Report

Public Rights-of-Way

(Curb Ramps)

Intersection ID: 46317	Main Street: MAGNASCO_LN	Cross Street: BREWER_DR	Location:	W
ADA ID: F85DCF80ADD3	Ramp Type: PerpDiag	Initial Pass/Fail: Fail	Overall Compliance: No	Severity Score: 10

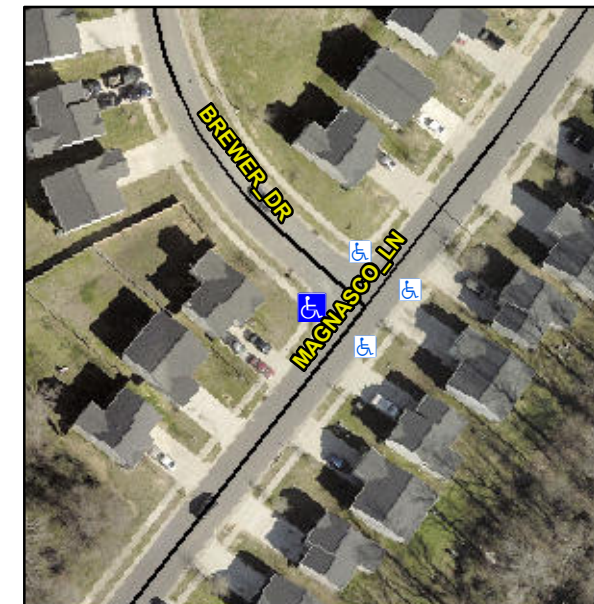
Not Found, R304.5.1, R304.5.3

Compliance	Description	Data	Compliance	Description	Data
N/A	Ramp Length (in)	50.0	Yes	Ramp Slope (%)	5.1
No	Ramp Width (in)	47.0	No	Ramp XSlope (%)	2.1
N/A	Flare Type LT	N/A	N/A	Flare Type RT	N/A
N/A	Flare Slope LT (%)	N/A	N/A	Flare Slope RT (%)	N/A
N/A	Flare Traversable LT?	N/A	N/A	Flare Traversable RT?	N/A
N/A	Landing Length (in)	N/A	N/A	DWS Provided?	N/A
N/A	Landing Width (in)	N/A	N/A	DWS Contrast?	N/A
N/A	Landing Slope (%)	N/A	N/A	DWS Length (in)	N/A
N/A	Landing X Slope (%)	N/A	N/A	DWS Full Width?	N/A
N/A	Landing Curb? (Y/N)	N/A	N/A	DWS Offset (in)	N/A
N/A	Shared Landing?	N/A			
N/A	Gutter Ponding?	N/A	N/A	Gutter Slope (%)	N/A
N/A	Gutter Lip Ht (in)	N/A	N/A	Gutter X Slope (%)	N/A
N/A	Painted X Walk1?	No	N/A	Painted X Walk2?	No
	X Walk 1 Direction	To SE		X Walk 2 Direction	To NE
N/A	X Walk 1 Width (in)	N/A	N/A	X Walk 2 Width (in)	N/A
	X Walk 1 Slope (%)	1.6		X Walk 2 Slope (%)	1.8
	X Walk 1 X Slope (%)	1.2		X Walk 2 X Slope (%)	1.8

N/A	Ramp inside XWalk1?	N/A	N/A	Ramp inside XWalk2?	N/A
	Road Slope (%)	3.0	N/A	Clear Space?	N/A
	Road X Slope (%)	0.0	N/A	Clear Space to XWalk (in)	N/A
N/A	Any Obstructions?	N/A	N/A	Storm Grate/Utility Hazard?	N/A
	Obstruction Type			Storm Grate/Utility Type	
		N/A			N/A
			Yes	Surface Condition? (G/P)	Good

Remove & Replace Curb Ramp With Two New Directional Ramps or Equivalent.
