# Access Compliance Report

## Public Rights-of-Way

### (Curb Ramps)

| Intersection ID: 48945 | Main Street: DAVID_JENNINGS_AV | Cross Street: CALDWELL_RIDGE_PY | Location: E |

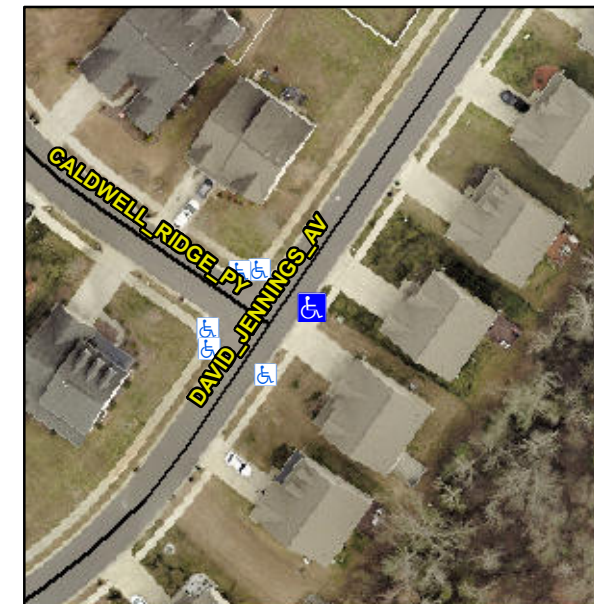
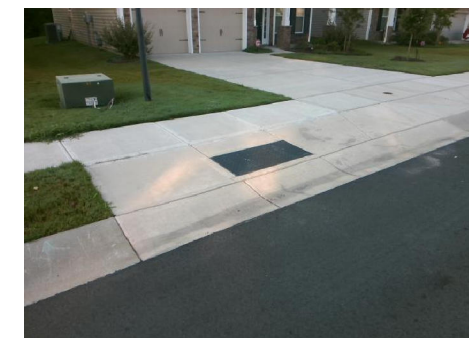
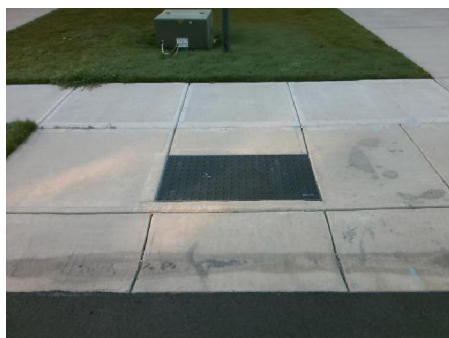
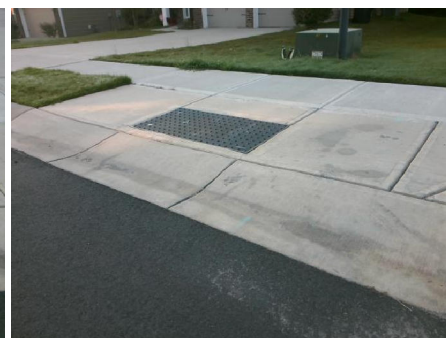
**Not Found, R305.2, R302.7, R304.5.4**

| Compliance | Description | Data | Compliance | Description | Data |
|---|---|---|---|---|---|
| N/A | Landing Curb? (Y/N) | No | No | DWS Offset (in) | 3.5 |
| No | Gutter Ponding? | Yes | No | Gutter Slope (%) | 7.2 |

**Remove & Replace Entire Ramp.**  
**Remove & Replace Gutter.**
