Access Compliance Report

Public Rights-of-Way

(Curb Ramps)

Intersection ID: 22834	Main Street: PEPPERDINE_DR	Cross Street: WHITNEY_HILL_RD	Location: NW
ADA ID: F86D597ADBA3	Ramp Type: PerpDiag	Initial Pass/Fail: Fail	Overall Compliance: No
		Severity Score: 25

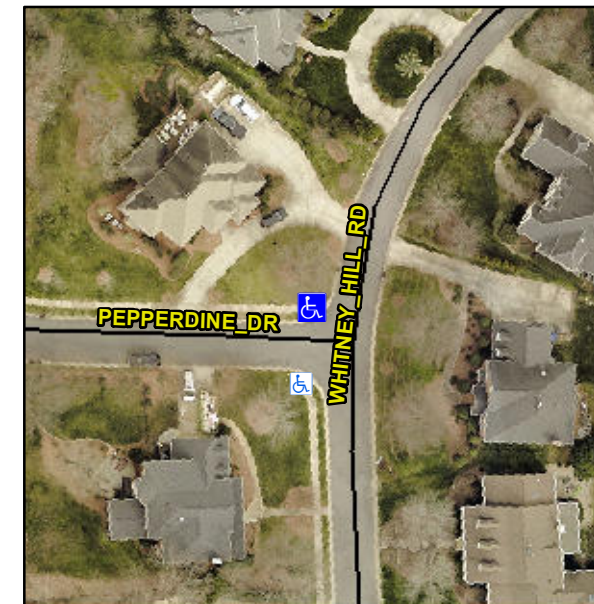
Not Found, R304.5.3

Compliance	Description	Data	Compliance	Description	Data
N/A	Ramp Length (in)	96.0	Yes	Ramp Slope (%)	5.2
Yes	Ramp Width (in)	48.0	No	Ramp XSlope (%)	11.2
N/A	Flare Type LT	N/A	N/A	Flare Type RT	N/A
N/A	Flare Slope LT (%)	N/A	N/A	Flare Slope RT (%)	N/A
N/A	Flare Traversable LT?	N/A	N/A	Flare Traversable RT?	N/A
N/A	Landing Length (in)	N/A	N/A	DWS Provided?	N/A
N/A	Landing Width (in)	N/A	N/A	DWS Contrast?	N/A
N/A	Landing Slope (%)	N/A	N/A	DWS Length (in)	N/A
N/A	Landing X Slope (%)	N/A	N/A	DWS Full Width?	N/A
N/A	Landing Curb? (Y/N)	N/A	N/A	DWS Offset (in)	N/A
N/A	Shared Landing?	N/A			
N/A	Gutter Ponding?	N/A	N/A	Gutter Slope (%)	N/A
N/A	Gutter Lip Ht (in)	N/A	N/A	Gutter X Slope (%)	N/A
N/A	Painted X Walk1?	No	N/A	Painted X Walk2?	No
	X Walk 1 Direction	To SE		X Walk 2 Direction	To E
N/A	X Walk 1 Width (in)	N/A	N/A	X Walk 2 Width (in)	N/A
	X Walk 1 Slope (%)	6.8		X Walk 2 Slope (%)	4.7
	X Walk 1 X Slope (%)	6.2		X Walk 2 X Slope (%)	4.6

N/A	Ramp inside XWalk1?	N/A	N/A	Ramp inside XWalk2?	N/A
	Road Slope (%)	9.6	N/A	Clear Space?	N/A
	Road X Slope (%)	0.5	N/A	Clear Space to XWalk (in)	N/A
N/A	Any Obstructions?	N/A	N/A	Storm Grate/Utility Hazard?	N/A
	Obstruction Type			Storm Grate/Utility Type	
		N/A			N/A
			Yes	Surface Condition? (G/P)	Good

Remove & Replace Curb Ramp With Two New Directional Ramps or Equivalent.
