# Access Compliance Report

## Public Rights-of-Way

### (Curb Ramps)

Intersection ID: 10035679	Main Street: RED_RUST_LN	Cross Street: N/A	Location: E
ADA ID: F8788FCBD0C8	Ramp Type: Perp	Initial Pass/Fail: Fail	Overall Compliance: No
		Severity Score: 12.5

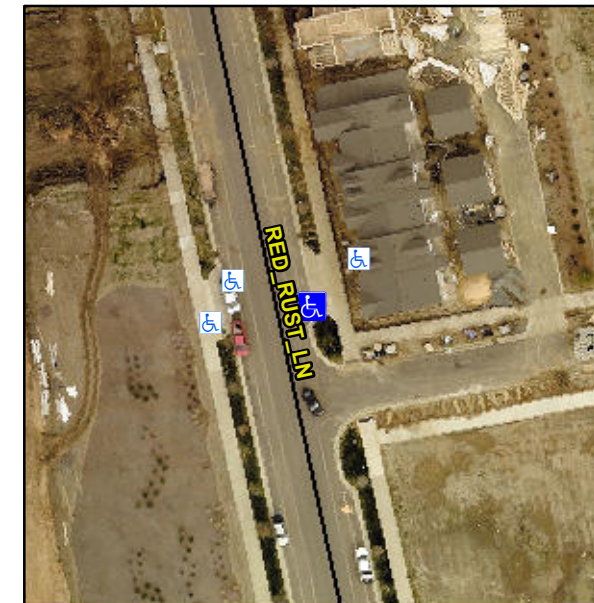
**Not Found, R304.2.2**

Compliance	Description	Data	Compliance	Description	Data
N/A	Ramp Length (in)	67.0	No	Ramp Slope (%)	10.3
Yes	Ramp Width (in)	60.0	Yes	Ramp XSlope (%)	0.4
N/A	Flare Type LT	N/A	N/A	Flare Type RT	N/A
N/A	Flare Slope LT (%)	N/A	N/A	Flare Slope RT (%)	N/A
N/A	Flare Traversable LT?	N/A	N/A	Flare Traversable RT?	N/A
N/A	Landing Length (in)	N/A	N/A	DWS Provided?	N/A
N/A	Landing Width (in)	N/A	N/A	DWS Contrast?	N/A
N/A	Landing Slope (%)	N/A	N/A	DWS Length (in)	N/A
N/A	Landing X Slope (%)	N/A	N/A	DWS Full Width?	N/A
N/A	Landing Curb? (Y/N)	N/A	N/A	DWS Offset (in)	N/A
N/A	Shared Landing?	N/A			
N/A	Gutter Ponding?	N/A	N/A	Gutter Slope (%)	N/A
N/A	Gutter Lip Ht (in)	N/A	N/A	Gutter X Slope (%)	N/A
N/A	Painted X Walk1?	No	N/A	Painted X Walk2?	N/A
	X Walk 1 Direction	To NW		X Walk 2 Direction	N/A
N/A	X Walk 1 Width (in)	N/A	N/A	X Walk 2 Width (in)	N/A
	X Walk 1 Slope (%)	3.9		X Walk 2 Slope (%)	N/A
	X Walk 1 X Slope (%)	3.4		X Walk 2 X Slope (%)	N/A

N/A	Ramp inside XWalk1?	N/A	N/A	Ramp inside XWalk2?	N/A
	Road Slope (%)	N/A	N/A	Clear Space?	N/A
	Road X Slope (%)	N/A	N/A	Clear Space to XWalk (in)	N/A
N/A	Any Obstructions?	N/A	N/A	Storm Grate/Utility Hazard?	N/A
	Obstruction Type			Storm Grate/Utility Type	
		N/A			N/A
			Yes	Surface Condition? (G/P)	Good

**Remove & Replace Entire Ramp.**

Total Cost: \$ 1850.00
