Access Compliance Report

Public Rights-of-Way

(Curb Ramps)

Intersection ID: N/A	Main Street: MORABLIN_DR	Cross Street: CARAGANA_CT	Location: NE
ADA ID: F884946143B2	Ramp Type: BlendTrans2	Initial Pass/Fail: Fail	Overall Compliance: No
Severity Score: 35			
Codes/Mitigation Info/Possible Solution		Field Measurements/Component Compliance

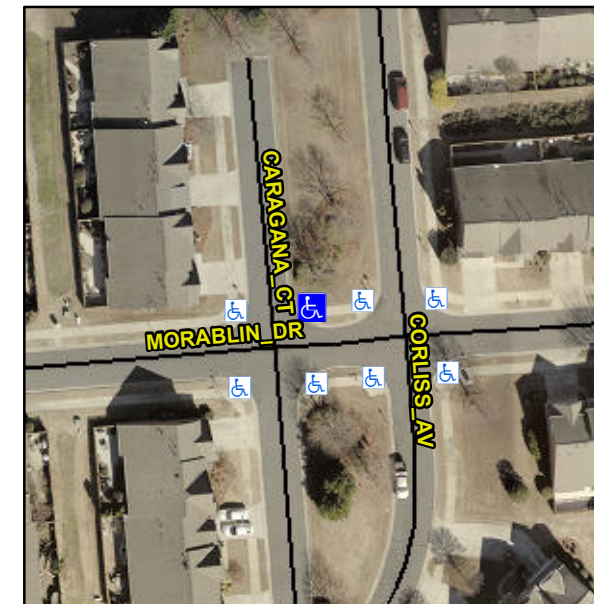
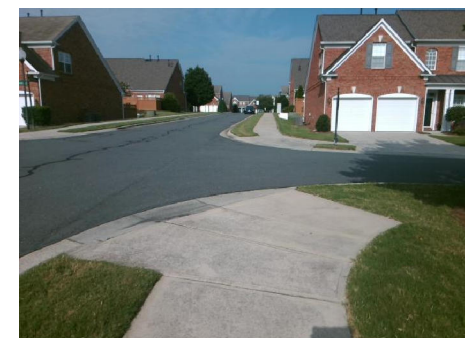
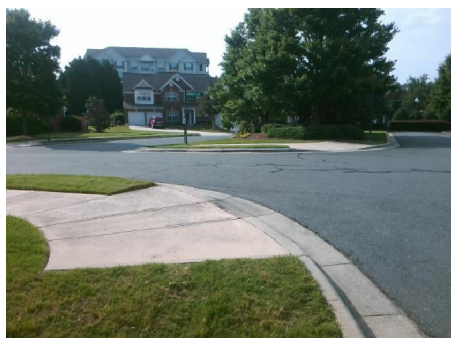
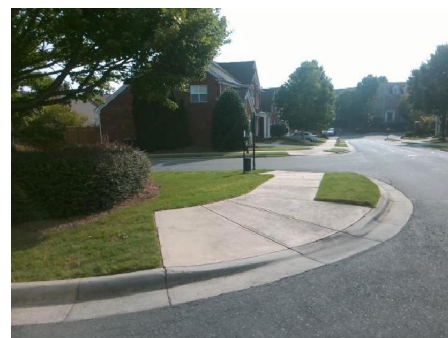
Compliance	Description	Data	Compliance	Description	Data
N/A	Ramp Length (in)	101.0	Yes	BlendTrans Slope (%)	4.2
No	Ramp Width (in)	26.0	Yes	BlendTrans XSlope (%)	0.1
N/A	Flare Type LT	N/A	N/A	Flare Type RT	N/A
N/A	Flare Slope LT (%)	N/A	N/A	Flare Slope RT (%)	N/A
N/A	Flare Traversable LT?	N/A	N/A	Flare Traversable RT?	N/A
N/A	Landing Length (in)	N/A	N/A	DWS Provided?	N/A
N/A	Landing Width (in)	N/A	N/A	DWS Contrast?	N/A
N/A	Landing Slope (%)	N/A	N/A	DWS Length (in)	N/A
N/A	Landing X Slope (%)	N/A	N/A	DWS Full Width?	N/A
N/A	Landing Curb? (Y/N)	N/A	N/A	DWS Offset (in)	N/A
N/A	Shared Landing?	N/A			
N/A	Gutter Ponding?	N/A	N/A	Gutter Slope (%)	N/A
N/A	Gutter Lip Ht (in)	N/A	N/A	Gutter X Slope (%)	N/A
N/A	Painted X Walk1?	No	N/A	Painted X Walk2?	No
	X Walk 1 Direction	To W		X Walk 2 Direction	To S
	X Walk 1 Width (in)	N/A		X Walk 2 Width (in)	N/A
	X Walk 1 Slope (%)	1.5		X Walk 2 Slope (%)	0.5
	X Walk 1 X Slope (%)	3.4		X Walk 2 X Slope (%)	3.3

N/A	Ramp inside XWalk1?	N/A	N/A	Ramp inside XWalk2?	N/A
	Road Slope (%)	1.4		Clear Space?	N/A
	Road X Slope (%)	1.9	N/A	Clear Space to XWalk (in)	N/A
N/A	Any Obstructions?	N/A	N/A	Storm Grate/Utility Hazard?	N/A
	Obstruction Type			Storm Grate/Utility Type	
		N/A			N/A
			Yes	Surface Condition? (G/P)	Good
			N/A	Curb Slope (%)	2.3

Remove & Replace Curb Ramp With Two New Directional Ramps or Equivalent.

R304.5.1
