# Access Compliance Report

## Public Rights-of-Way

### (Curb Ramps)

Intersection ID: 19938	Main Street: ARCHDALE_DR	Cross Street: MONTCREST_DR	Location: SE
ADA ID: F884C5E08CE3	Ramp Type: PerpDiag	Initial Pass/Fail: Fail	Overall Compliance: No
Severity Score: 12.5			
Codes/Mitigation Info/Possible Solution		Field Measurements/Component Compliance

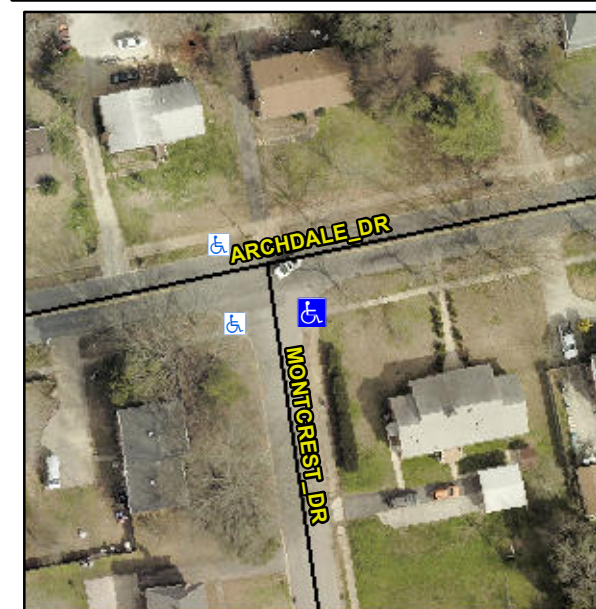
**Not Found, R304.5.3**

Compliance	Description	Data	Compliance	Description	Data
N/A	Ramp Length (in)	83.0	Yes	Ramp Slope (%)	5.6
Yes	Ramp Width (in)	48.0	No	Ramp XSlope (%)	5.6
N/A	Flare Type LT	N/A	N/A	Flare Type RT	N/A
N/A	Flare Slope LT (%)	N/A	N/A	Flare Slope RT (%)	N/A
N/A	Flare Traversable LT?	N/A	N/A	Flare Traversable RT?	N/A
N/A	Landing Length (in)	N/A	N/A	DWS Provided?	N/A
N/A	Landing Width (in)	N/A	N/A	DWS Contrast?	N/A
N/A	Landing Slope (%)	N/A	N/A	DWS Length (in)	N/A
N/A	Landing X Slope (%)	N/A	N/A	DWS Full Width?	N/A
N/A	Landing Curb? (Y/N)	N/A	N/A	DWS Offset (in)	N/A
N/A	Shared Landing?	N/A			
N/A	Gutter Ponding?	N/A	N/A	Gutter Slope (%)	N/A
N/A	Gutter Lip Ht (in)	N/A	N/A	Gutter X Slope (%)	N/A
N/A	Painted X Walk1?	No	N/A	Painted X Walk2?	No
	X Walk 1 Direction	To N		X Walk 2 Direction	To W
N/A	X Walk 1 Width (in)	N/A	N/A	X Walk 2 Width (in)	N/A
	X Walk 1 Slope (%)	1.3		X Walk 2 Slope (%)	0.4
	X Walk 1 X Slope (%)	1.6		X Walk 2 X Slope (%)	0.2

N/A	Ramp inside XWalk1?	N/A	N/A	Ramp inside XWalk2?	N/A
	Road Slope (%)	3.3	N/A	Clear Space?	N/A
	Road X Slope (%)	1.2	N/A	Clear Space to XWalk (in)	N/A
N/A	Any Obstructions?	N/A	N/A	Storm Grate/Utility Hazard?	N/A
	Obstruction Type			Storm Grate/Utility Type	
		N/A			N/A
		Yes		Surface Condition? (G/P)	Good

**Remove & Replace Curb Ramp With Two New Directional Ramps or Equivalent.**

Total Cost: \$ 3200.00
