# Access Compliance Report

## Public Rights-of-Way (Curb Ramps)

| Intersection ID: 31756 | Main Street: FIRST_RUN_CT | Cross Street: PAPER_BIRCH_DR | Location: SW |
| ADA ID: F886ABF6D6D8 | Ramp Type: Perp | Initial Pass/Fail: Fail | Overall Compliance: No |

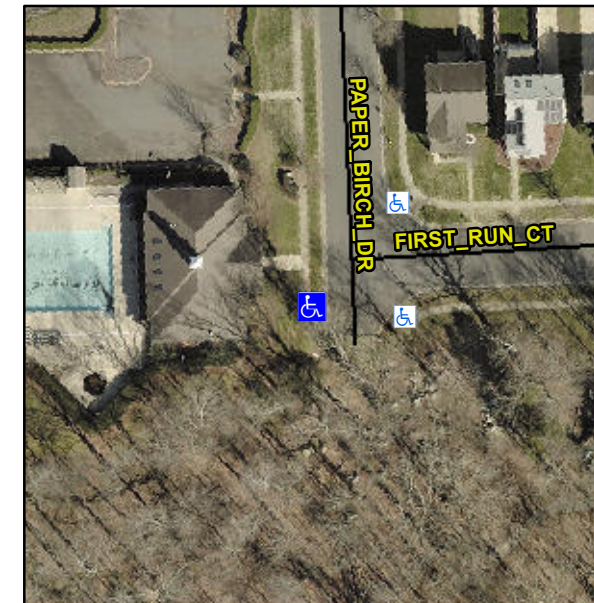
**Not Found, R304.5.1**

| Compliance | Description | Data | Compliance | Description | Data |
|---|---|---|---|---|---|
| No | Ramp Width (in) | 47.0 | Yes | Ramp XSlope (%) | 0.9 |

**Remove & Replace Entire Ramp.**

Total Cost: \$ 1850.00
