# Access Compliance Report

## Public Rights-of-Way

### (Curb Ramps)

| Intersection ID: 19937 | Main Street: S_TRYON_ST | Cross Street: THORNFIELD_RD | Location: NW |

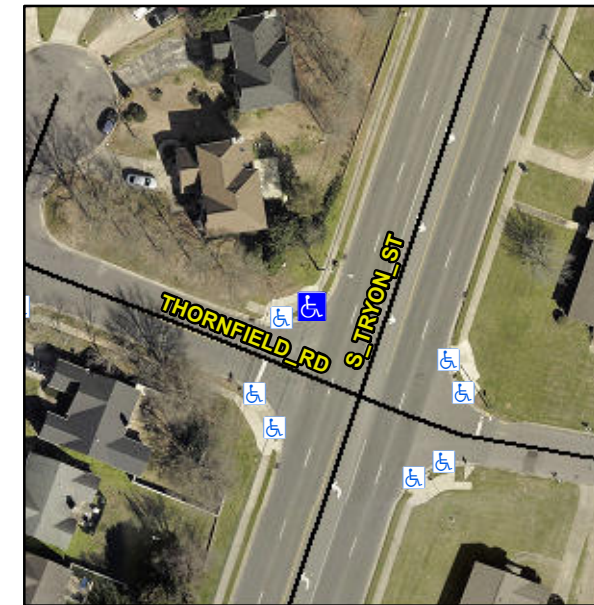
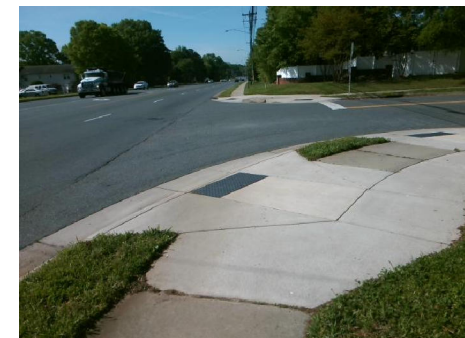
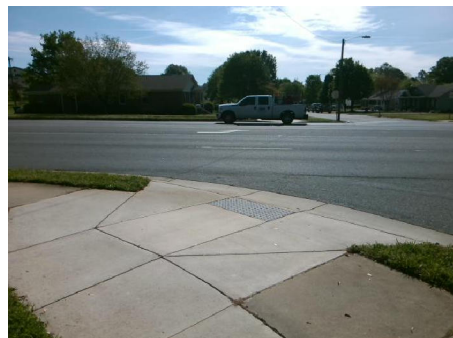
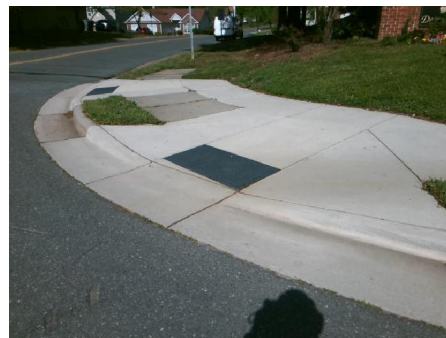
**Not Found, R305.2**

| Compliance | Description | Data | Compliance | Description | Data |
|---|---|---|---|---|---|
| N/A | Landing Curb? (Y/N) | No | No | DWS Offset (in) | 4.5 |
| | | | No | Curb Slope (%) | 9.0 |

**Remove & Replace Curb Ramp With Two New Directional Ramps or Equivalent.**

Total Cost: \$ 3200.00
