# Access Compliance Report

## Public Rights-of-Way

### (Curb Ramps)

Intersection ID: 4014	Main Street: DAVIS_LAKE_PY	Cross Street: DOWNING_CREEK_DR	Location: S
ADA ID: F88BECFE39D2	Ramp Type: Perp	Initial Pass/Fail: Fail	Overall Compliance: No
Severity Score: 50			
Codes/Mitigation Info/Possible Solution		Field Measurements/Component Compliance

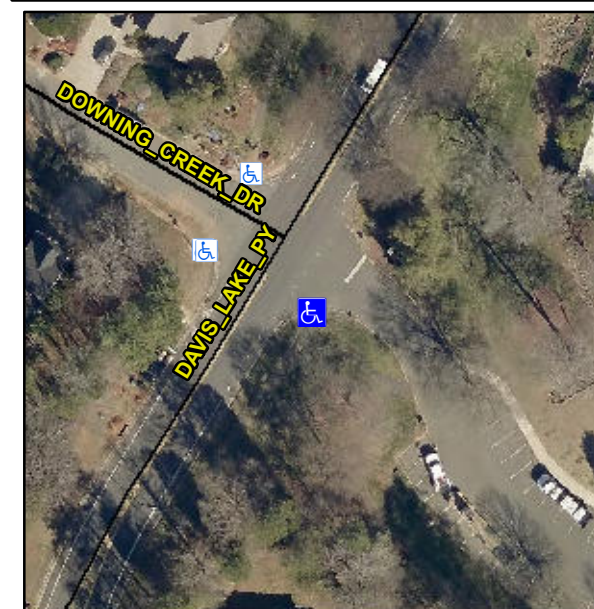
**Not Found, R304.2.2, R304.5.3**

Compliance	Description	Data	Compliance	Description	Data
N/A	Ramp Length (in)	48.0	No	Ramp Slope (%)	16.9
Yes	Ramp Width (in)	51.0	No	Ramp XSlope (%)	10.2
N/A	Flare Type LT	N/A	N/A	Flare Type RT	N/A
N/A	Flare Slope LT (%)	N/A	N/A	Flare Slope RT (%)	N/A
N/A	Flare Traversable LT?	N/A	N/A	Flare Traversable RT?	N/A
N/A	Landing Length (in)	N/A	N/A	DWS Provided?	N/A
N/A	Landing Width (in)	N/A	N/A	DWS Contrast?	N/A
N/A	Landing Slope (%)	N/A	N/A	DWS Length (in)	N/A
N/A	Landing X Slope (%)	N/A	N/A	DWS Full Width?	N/A
N/A	Landing Curb? (Y/N)	N/A	N/A	DWS Offset (in)	N/A
N/A	Shared Landing?	N/A			
N/A	Gutter Ponding?	N/A	N/A	Gutter Slope (%)	N/A
N/A	Gutter Lip Ht (in)	N/A	N/A	Gutter X Slope (%)	N/A
N/A	Painted X Walk1?	No	N/A	Painted X Walk2?	N/A
	X Walk 1 Direction	To NE		X Walk 2 Direction	N/A
N/A	X Walk 1 Width (in)	N/A	N/A	X Walk 2 Width (in)	N/A
	X Walk 1 Slope (%)	9.2		X Walk 2 Slope (%)	N/A
	X Walk 1 X Slope (%)	6.7		X Walk 2 X Slope (%)	N/A

N/A	Ramp inside XWalk1?	N/A	N/A	Ramp inside XWalk2?	N/A
	Road Slope (%)	N/A	N/A	Clear Space?	N/A
	Road X Slope (%)	N/A	N/A	Clear Space to XWalk (in)	N/A
N/A	Any Obstructions?	N/A	N/A	Storm Grate/Utility Hazard?	N/A
	Obstruction Type			Storm Grate/Utility Type	
		N/A			N/A
			Yes	Surface Condition? (G/P)	Good

**Remove & Replace Entire Ramp.**

Total Cost: \$ 1850.00
