Access Compliance Report

Public Rights-of-Way

(Curb Ramps)

Intersection ID: 11913	Main Street: MIDLAND_AV	Cross Street: BEAUX_ST	Location: W
ADA ID: F88D3148C998	Ramp Type: Perp	Initial Pass/Fail: Fail	Overall Compliance: No
Severity Score: 10			
Codes/Mitigation Info/Possible Solution		Field Measurements/Component Compliance

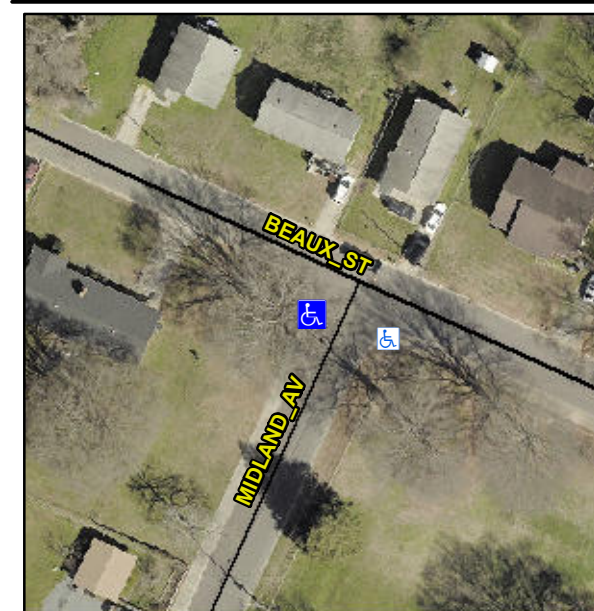
Not Found, R304.5.1, R304.5.3

Compliance	Description	Data	Compliance	Description	Data
N/A	Ramp Length (in)	72.0	Yes	Ramp Slope (%)	5.1
No	Ramp Width (in)	43.0	No	Ramp XSlope (%)	3.0
N/A	Flare Type LT	N/A	N/A	Flare Type RT	N/A
N/A	Flare Slope LT (%)	N/A	N/A	Flare Slope RT (%)	N/A
N/A	Flare Traversable LT?	N/A	N/A	Flare Traversable RT?	N/A
N/A	Landing Length (in)	N/A	N/A	DWS Provided?	N/A
N/A	Landing Width (in)	N/A	N/A	DWS Contrast?	N/A
N/A	Landing Slope (%)	N/A	N/A	DWS Length (in)	N/A
N/A	Landing X Slope (%)	N/A	N/A	DWS Full Width?	N/A
N/A	Landing Curb? (Y/N)	N/A	N/A	DWS Offset (in)	N/A
N/A	Shared Landing?	N/A			
N/A	Gutter Ponding?	N/A	N/A	Gutter Slope (%)	N/A
N/A	Gutter Lip Ht (in)	N/A	N/A	Gutter X Slope (%)	N/A
N/A	Painted X Walk1?	No	N/A	Painted X Walk2?	N/A
	X Walk 1 Direction	To SE		X Walk 2 Direction	N/A
N/A	X Walk 1 Width (in)	N/A	N/A	X Walk 2 Width (in)	N/A
	X Walk 1 Slope (%)	2.8		X Walk 2 Slope (%)	N/A
	X Walk 1 X Slope (%)	3.9		X Walk 2 X Slope (%)	N/A

N/A	Ramp inside XWalk1?	N/A	N/A	Ramp inside XWalk2?	N/A
	Road Slope (%)	N/A	N/A	Clear Space?	N/A
	Road X Slope (%)	N/A	N/A	Clear Space to XWalk (in)	N/A
N/A	Any Obstructions?	N/A	N/A	Storm Grate/Utility Hazard?	N/A
	Obstruction Type			Storm Grate/Utility Type	
		N/A			N/A
			Yes	Surface Condition? (G/P)	Good

Possible Solutions:

Remove & Replace Entire Ramp.
