Access Compliance Report

Public Rights-of-Way

(Curb Ramps)

Intersection ID: N/A	Main Street: STEELE_CREEK_RD	Cross Street: RACHEL_FREEMAN_WY	Location: NW
ADA ID: F88FED776710	Ramp Type: PerpDiag	Initial Pass/Fail: Fail	Overall Compliance: No
Severity Score: 12.5			
Codes/Mitigation Info/Possible Solution		Field Measurements/Component Compliance

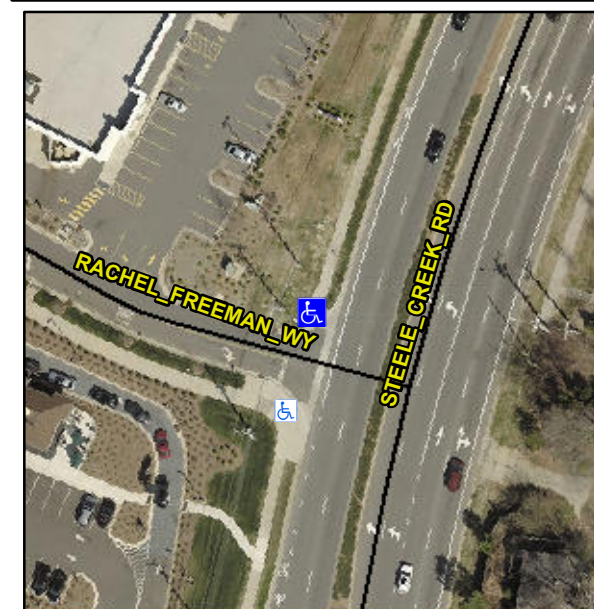
Not Found, R304.5.3

Compliance	Description	Data	Compliance	Description	Data
N/A	Ramp Length (in)	71.0	Yes	Ramp Slope (%)	7.8
Yes	Ramp Width (in)	48.0	No	Ramp XSlope (%)	5.5
N/A	Flare Type LT	N/A	N/A	Flare Type RT	N/A
N/A	Flare Slope LT (%)	N/A	N/A	Flare Slope RT (%)	N/A
N/A	Flare Traversable LT?	N/A	N/A	Flare Traversable RT?	N/A
N/A	Landing Length (in)	N/A	N/A	DWS Provided?	N/A
N/A	Landing Width (in)	N/A	N/A	DWS Contrast?	N/A
N/A	Landing Slope (%)	N/A	N/A	DWS Length (in)	N/A
N/A	Landing X Slope (%)	N/A	N/A	DWS Full Width?	N/A
N/A	Landing Curb? (Y/N)	N/A	N/A	DWS Offset (in)	N/A
N/A	Shared Landing?	N/A			
N/A	Gutter Ponding?	N/A	N/A	Gutter Slope (%)	N/A
N/A	Gutter Lip Ht (in)	N/A	N/A	Gutter X Slope (%)	N/A
N/A	Painted X Walk1?	No	N/A	Painted X Walk2?	No
	X Walk 1 Direction	To SW		X Walk 2 Direction	To SE
N/A	X Walk 1 Width (in)	N/A	N/A	X Walk 2 Width (in)	N/A
	X Walk 1 Slope (%)	1.8		X Walk 2 Slope (%)	0.3
	X Walk 1 X Slope (%)	3.5		X Walk 2 X Slope (%)	0.1

N/A	Ramp inside XWalk1?	N/A	N/A	Ramp inside XWalk2?	N/A
	Road Slope (%)	1.9	N/A	Clear Space?	N/A
	Road X Slope (%)	4.8	N/A	Clear Space to XWalk (in)	N/A
N/A	Any Obstructions?	N/A	N/A	Storm Grate/Utility Hazard?	N/A
	Obstruction Type			Storm Grate/Utility Type	
		N/A			N/A
		Yes		Surface Condition? (G/P)	Good

Possible Solutions:

Remove & Replace Curb Ramp With Two New Directional Ramps or Equivalent.
