Access Compliance Report

Public Rights-of-Way

(Curb Ramps)

| Intersection ID: 19937 | Main Street: S_TRYON_ST | Cross Street: THORNFIELD_RD | Location: SW |

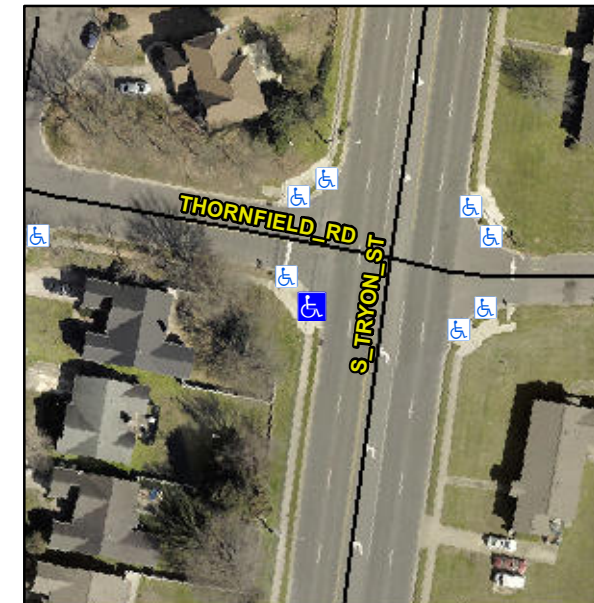
Not Found, R305.2, R304.5.3

| Compliance | Description | Data | Compliance | Description | Data |
|---|---|---|---|---|---|
| N/A | Landing Curb? (Y/N) | No | No | DWS Offset (in) | 5.5 |
| Yes | Gutter Lip Ht (in) | 0.0 | No | Gutter X Slope (%) | 3.3 |

Remove & Replace Curb Ramp With Two New Directional Ramps or Equivalent. Remove & Replace Gutter.

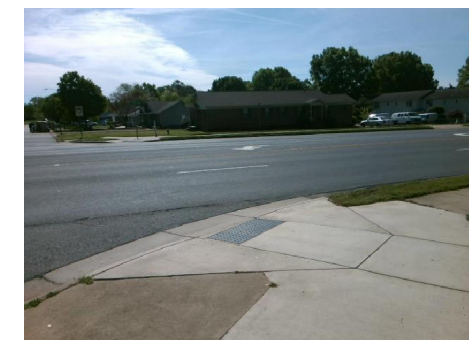
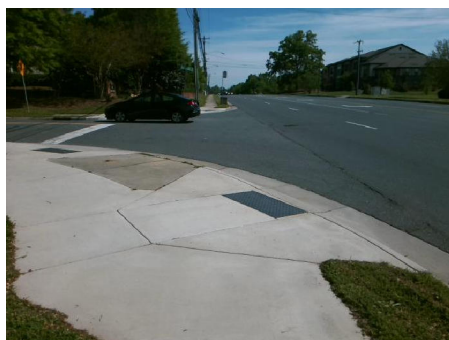
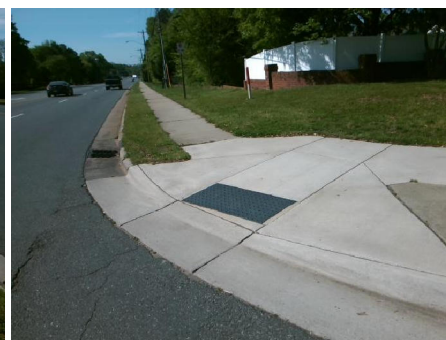
| Compliance | Description | Data | Compliance | Description | Data |
|---|---|---|---|---|---|
| | | | Yes | Surface Condition? (G/P) | Good |
