Access Compliance Report Public Rights-of-Way (Curb Ramps)

Intersection ID: 19195 Main Street: CLOISTER DR **Cross Street: PROVIDENCE_RD** Location: W **ADA ID: F8ABAB7864A0** Ramp Type: ParaDiag Initial Pass/Fail: Fail **Overall Compliance: No Severity Score:** 35

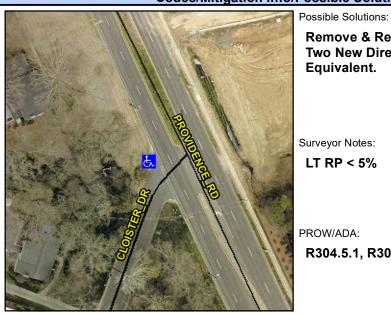
Surveyor Notes: LT RP < 5%

| Compliance Description Data Compliance Description | | | | | Data |
|--|---|---|---|---|---|
| No | Ramp Width LT (in) | 39.0 | No | Ramp Width RT (in) | 39.5 |
| Yes | Ramp Slope LT (%) | 2.2 | No | Ramp Slope RT (%) | 13.1 |
| No | Ramp XSlope LT (%) | 3.8 | Yes | Ramp XSlope RT (%) | 1.5 |

Remove & Replace Curb Ramp With Two New Directional Ramps or Equivalent.

R304.5.1, R304.5.3, R304.3.2
