Access Compliance Report

Public Rights-of-Way

(Curb Ramps)

Intersection ID: 53758	Main Street: PROSPERITY RIDGE RD	Cross Street: PROSPERITY RIDGE RD	Location:	E
ADA ID: F8AC98EDBBAD	Ramp Type: Perp	Initial Pass/Fail: Fail	Overall Compliance: No	Severity Score: 12.5
Codes/Mitigation Info/Possible Solution		Field Measurements/Component Compliance

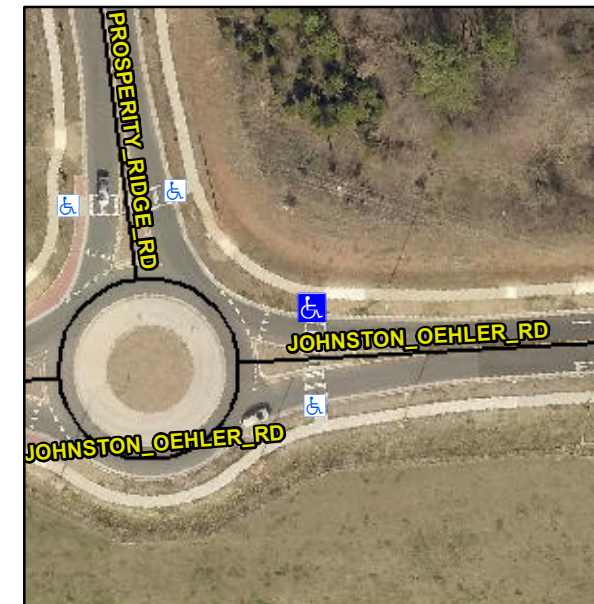
Compliance	Description	Data	Compliance	Description	Data
N/A	Ramp Length (in)	105.0	No	Ramp Slope (%)	9.8
Yes	Ramp Width (in)	68.5	Yes	Ramp XSlope (%)	0.6
N/A	Flare Type LT	N/A	N/A	Flare Type RT	N/A
N/A	Flare Slope LT (%)	N/A	N/A	Flare Slope RT (%)	N/A
N/A	Flare Traversable LT?	N/A	N/A	Flare Traversable RT?	N/A
N/A	Landing Length (in)	N/A	N/A	DWS Provided?	N/A
N/A	Landing Width (in)	N/A	N/A	DWS Contrast?	N/A
N/A	Landing Slope (%)	N/A	N/A	DWS Length (in)	N/A
N/A	Landing X Slope (%)	N/A	N/A	DWS Full Width?	N/A
N/A	Landing Curb? (Y/N)	N/A	N/A	DWS Offset (in)	N/A
N/A	Shared Landing?	N/A			
N/A	Gutter Ponding?	N/A	N/A	Gutter Slope (%)	N/A
N/A	Gutter Lip Ht (in)	N/A	N/A	Gutter X Slope (%)	N/A
N/A	Painted X Walk1?	Yes	N/A	Painted X Walk2?	N/A
	X Walk 1 Direction	To S		X Walk 2 Direction	N/A
N/A	X Walk 1 Width (in)	110.0	N/A	X Walk 2 Width (in)	N/A
	X Walk 1 Slope (%)	4.4		X Walk 2 Slope (%)	N/A
	X Walk 1 X Slope (%)	1.2		X Walk 2 X Slope (%)	N/A

N/A	Ramp inside XWalk1?	Yes	N/A	Ramp inside XWalk2?	N/A
	Road Slope (%)	N/A	N/A	Clear Space?	N/A
	Road X Slope (%)	N/A	N/A	Clear Space to XWalk (in)	N/A
N/A	Any Obstructions?	N/A	N/A	Storm Grate/Utility Hazard?	N/A
	Obstruction Type			Storm Grate/Utility Type	
		N/A			N/A
			Yes	Surface Condition? (G/P)	Good

Possible Solutions:

Remove & Replace Entire Ramp.

R304.2.2

\$ 1850.00
