Access Compliance Report

Public Rights-of-Way

(Curb Ramps)

| Intersection ID: 48763 | Main Street: SONOMA_VALLEY_DR | Cross Street: N/A | Location: S |

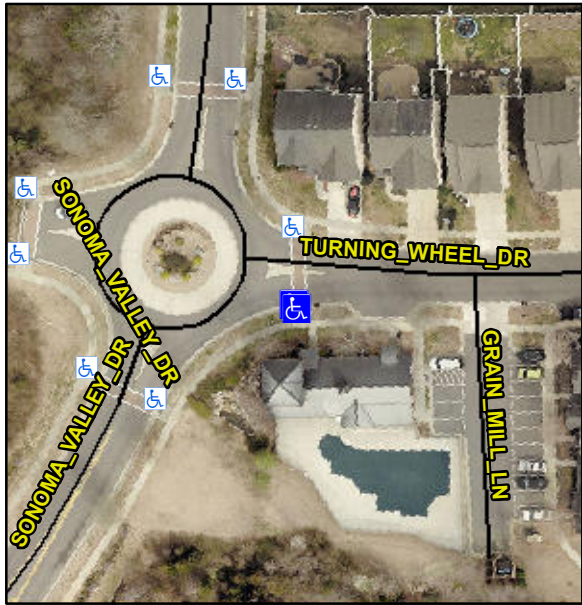
| ADA ID: F8BD0AD8C767 | Ramp Type: Perp | Initial Pass/Fail: Fail | Overall Compliance: No |

| Codes/Mitigation Info/Possible Solution | | | Field Measurements/Component Compliance | | | | | |
|---|--|---|---|---|---|---|---|---|
| | Remove & Replace Entire Ramp. | | N/A | Ramp Length (in) | 76.0 | No | Ramp Slope (%) | 8.7 |
| | | | No | Ramp Width (in) | 46.5 | Yes | Ramp XSlope (%) | 1.4 |
| PROW/ADA: | | Not Found, R304.5.1, R304.2.2 | N/A | Shared Landing? | N/A | | | |

| Codes/Mitigation Info/Possible Solution | | | Field Measurements/Component Compliance | | | | | |
|---|--|---|---|---|---|---|---|---|
| <p>Street 1 Name TURNING WHEEL DR</p> <p>Stop Condition-Street 2 YieldSign</p> <p>Street 2 Name N/A</p> <p>Stop Condition-Street 1 N/A</p> | Possible Solutions: | | Compliance | Description | Data | Compliance | Description | Data |
| Total Cost: | | \$ 1850.00 | | | | | | |
