Access Compliance Report

Public Rights-of-Way

(Curb Ramps)

Intersection ID: 20640	Main Street: S_TRYON_ST	Cross Street: YAGER_CREEK_DR	Location: N
ADA ID: F8BD30C637F9	Ramp Type: Para	Initial Pass/Fail: Fail	Overall Compliance: No
Severity Score: 25			
Codes/Mitigation Info/Possible Solution		Field Measurements/Component Compliance

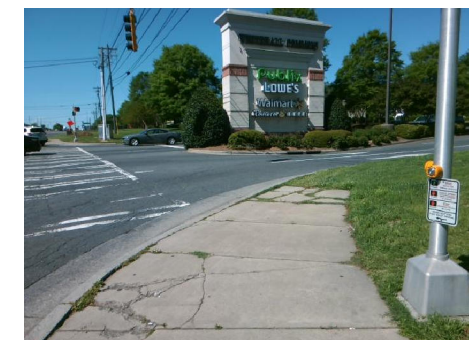
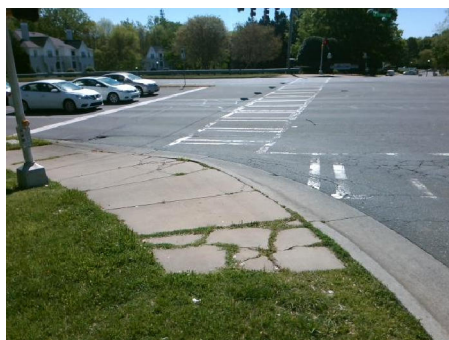
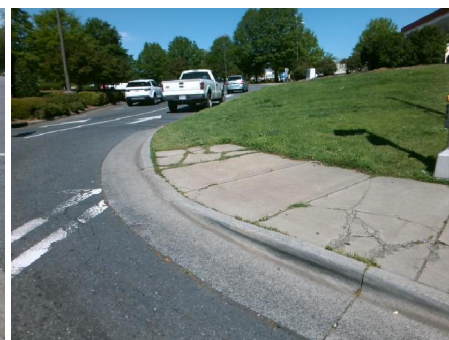
RT RP < 5%

Compliance	Description	Data	Compliance	Description	Data
N/A	Ramp Length LT (in)	41.0	N/A	Ramp Length RT (in)	43.0
Yes	Ramp Width LT (in)	61.0	Yes	Ramp Width RT (in)	88.0
No	Ramp Slope LT (%)	10.6	Yes	Ramp Slope RT (%)	4.9
No	Ramp XSlope LT (%)	6.0	No	Ramp XSlope RT (%)	3.5
N/A	Landing Length (in)	N/A	N/A	DWS Provided?	N/A
N/A	Landing Width (in)	N/A	N/A	DWS Contrast?	N/A
N/A	Landing Slope (%)	N/A	N/A	DWS Length (in)	N/A
N/A	Landing X Slope (%)	N/A	N/A	DWS Full Width?	N/A
N/A	Landing Curb? (Y/N)	N/A	N/A	DWS Offset (in)	N/A
N/A	Shared Landing?	N/A			
N/A	Gutter Ponding?	N/A	N/A	Gutter Slope (%)	N/A
N/A	Gutter Lip Ht (in)	N/A	N/A	Gutter X Slope (%)	N/A
N/A	Painted X Walk1?	Yes	N/A	Painted X Walk2?	N/A
	X Walk 1 Direction	To SW		X Walk 2 Direction	N/A
N/A	X Walk 1 Width (in)	110.5	N/A	X Walk 2 Width (in)	N/A
	X Walk 1 Slope (%)	4.9		X Walk 2 Slope (%)	N/A
	X Walk 1 X Slope (%)	4.4		X Walk 2 X Slope (%)	N/A
N/A	Ramp inside XWalk1?	No	N/A	Ramp inside XWalk2?	N/A

Road Slope (%)	N/A	N/A	Clear Space?	N/A
	Road X Slope (%)	N/A	N/A	Clear Space to XWalk (in)	N/A
N/A	Any Obstructions?	N/A	N/A	Storm Grate/Utility Hazard?	N/A
	Obstruction Type			Storm Grate/Utility Type	
		N/A			N/A
			Yes	Surface Condition? (G/P)	Good
			N/A	Curb Slope (%)	6.0

Possible Solutions:

**Remove & Replace Entire Ramp.
Restripe Crosswalk.**

R304.3.2, R304.5.3
