Access Compliance Report

Public Rights-of-Way

(Curb Ramps)

Intersection ID: 46734	Main Street: BOBHOUSE_DR	Cross Street: THREATT_WOODS_DR	Location: SE
ADA ID: F8C83DF1C828	Ramp Type: PerpDiag	Initial Pass/Fail: Fail	Overall Compliance: No
Severity Score: 8.75			
Codes/Mitigation Info/Possible Solution		Field Measurements/Component Compliance

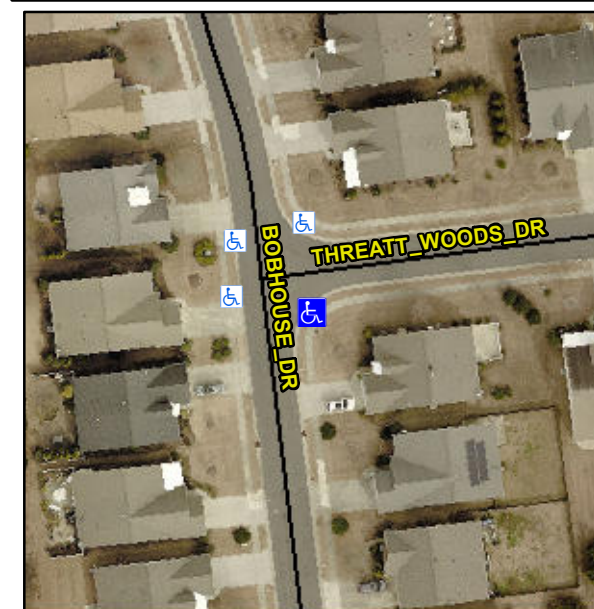
Not Found, R304.5.1

Compliance	Description	Data	Compliance	Description	Data
N/A	Ramp Length (in)	48.0	Yes	Ramp Slope (%)	5.4
No	Ramp Width (in)	41.0	Yes	Ramp XSlope (%)	0.1
N/A	Flare Type LT	N/A	N/A	Flare Type RT	N/A
N/A	Flare Slope LT (%)	N/A	N/A	Flare Slope RT (%)	N/A
N/A	Flare Traversable LT?	N/A	N/A	Flare Traversable RT?	N/A
N/A	Landing Length (in)	N/A	N/A	DWS Provided?	N/A
N/A	Landing Width (in)	N/A	N/A	DWS Contrast?	N/A
N/A	Landing Slope (%)	N/A	N/A	DWS Length (in)	N/A
N/A	Landing X Slope (%)	N/A	N/A	DWS Full Width?	N/A
N/A	Landing Curb? (Y/N)	N/A	N/A	DWS Offset (in)	N/A
N/A	Shared Landing?	N/A			
N/A	Gutter Ponding?	N/A	N/A	Gutter Slope (%)	N/A
N/A	Gutter Lip Ht (in)	N/A	N/A	Gutter X Slope (%)	N/A
N/A	Painted X Walk1?	No	N/A	Painted X Walk2?	No
	X Walk 1 Direction	To NE		X Walk 2 Direction	To NW
N/A	X Walk 1 Width (in)	N/A	N/A	X Walk 2 Width (in)	N/A
	X Walk 1 Slope (%)	3.8		X Walk 2 Slope (%)	2.3
	X Walk 1 X Slope (%)	1.0		X Walk 2 X Slope (%)	3.1

N/A	Ramp inside XWalk1?	N/A	N/A	Ramp inside XWalk2?	N/A
	Road Slope (%)	0.1	N/A	Clear Space?	N/A
	Road X Slope (%)	3.2	N/A	Clear Space to XWalk (in)	N/A
N/A	Any Obstructions?	N/A	N/A	Storm Grate/Utility Hazard?	N/A
	Obstruction Type			Storm Grate/Utility Type	
		N/A			N/A
		Yes		Surface Condition? (G/P)	Good

Remove & Replace Curb Ramp With Two New Directional Ramps or Equivalent.
