# Access Compliance Report

## Public Rights-of-Way

### (Curb Ramps)

Intersection ID: 3683	Main Street: BROMPTON_LN	Cross Street: DAVIS_LAKE_PY	Location: SW
ADA ID: F8C89B390152	Ramp Type: Perp	Initial Pass/Fail: Fail	Overall Compliance: No
Severity Score: 10			
Codes/Mitigation Info/Possible Solution		Field Measurements/Component Compliance

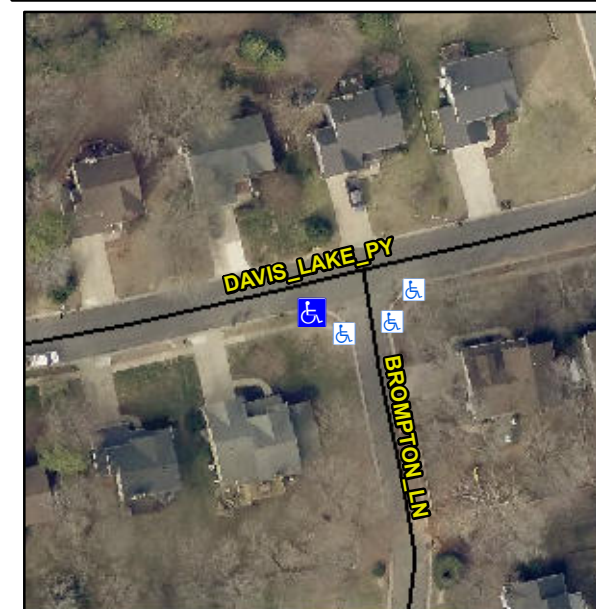
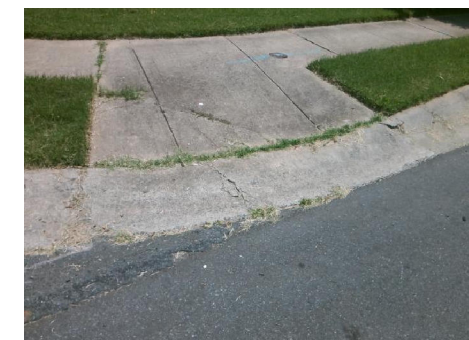
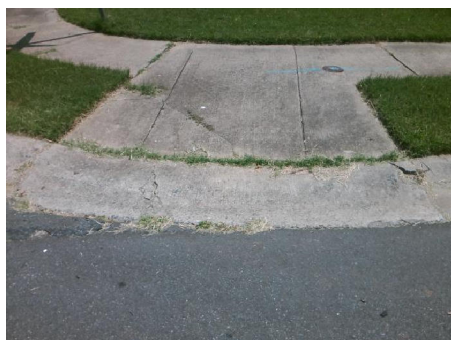
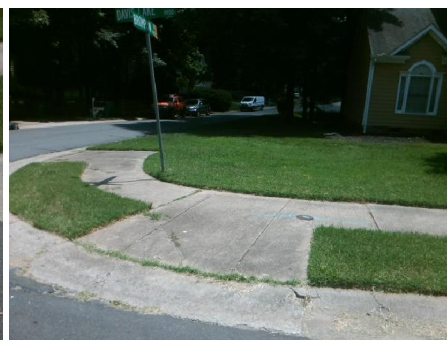
**Not Found, R304.5.1, R304.5.3**

Compliance	Description	Data	Compliance	Description	Data
N/A	Ramp Length (in)	48.0	Yes	Ramp Slope (%)	8.3
No	Ramp Width (in)	47.0	No	Ramp XSlope (%)	4.6
N/A	Flare Type LT	N/A	N/A	Flare Type RT	N/A
N/A	Flare Slope LT (%)	N/A	N/A	Flare Slope RT (%)	N/A
N/A	Flare Traversable LT?	N/A	N/A	Flare Traversable RT?	N/A
N/A	Landing Length (in)	N/A	N/A	DWS Provided?	N/A
N/A	Landing Width (in)	N/A	N/A	DWS Contrast?	N/A
N/A	Landing Slope (%)	N/A	N/A	DWS Length (in)	N/A
N/A	Landing X Slope (%)	N/A	N/A	DWS Full Width?	N/A
N/A	Landing Curb? (Y/N)	N/A	N/A	DWS Offset (in)	N/A
N/A	Shared Landing?	N/A			
N/A	Gutter Ponding?	N/A	N/A	Gutter Slope (%)	N/A
N/A	Gutter Lip Ht (in)	N/A	N/A	Gutter X Slope (%)	N/A
N/A	Painted X Walk1?	No	N/A	Painted X Walk2?	N/A
	X Walk 1 Direction	To N		X Walk 2 Direction	N/A
N/A	X Walk 1 Width (in)	N/A	N/A	X Walk 2 Width (in)	N/A
	X Walk 1 Slope (%)	5.4		X Walk 2 Slope (%)	N/A
	X Walk 1 X Slope (%)	2.2		X Walk 2 X Slope (%)	N/A

N/A	Ramp inside XWalk1?	N/A	N/A	Ramp inside XWalk2?	N/A
	Road Slope (%)	N/A	N/A	Clear Space?	N/A
	Road X Slope (%)	N/A	N/A	Clear Space to XWalk (in)	N/A
N/A	Any Obstructions?	N/A	N/A	Storm Grate/Utility Hazard?	N/A
	Obstruction Type			Storm Grate/Utility Type	
		N/A			N/A
			Yes	Surface Condition? (G/P)	Good

**Remove & Replace Entire Ramp.**
