Access Compliance Report

Public Rights-of-Way

(Curb Ramps)

Intersection ID: 16563	Main Street: AMITY_PL	Cross Street: BOSTON AV	Location: SW
ADA ID: F8E8A6D37026	Ramp Type: BlendTrans2	Initial Pass/Fail: Fail	Overall Compliance: No
		Severity Score: 8.75

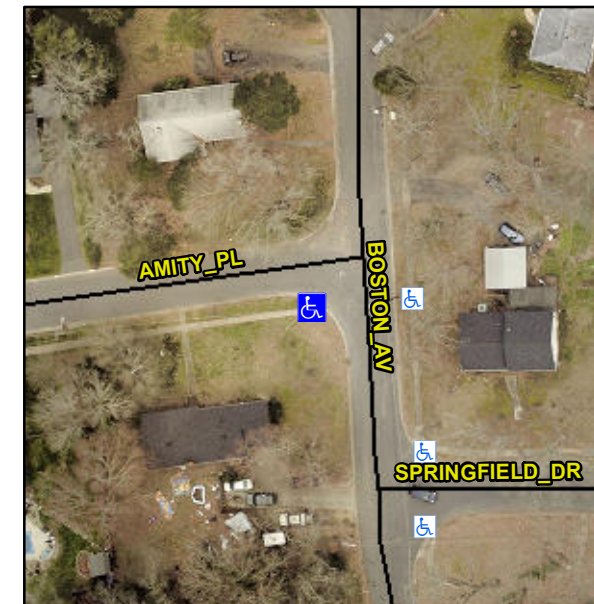
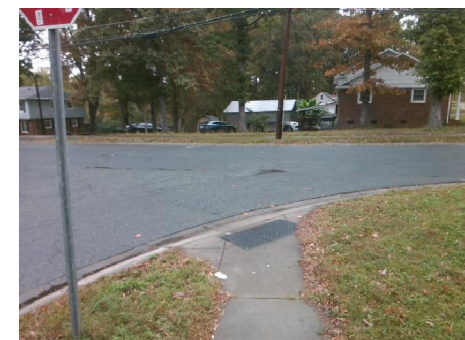
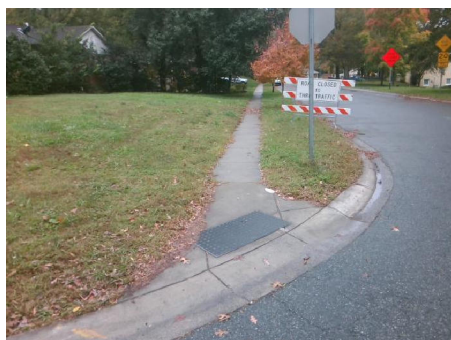
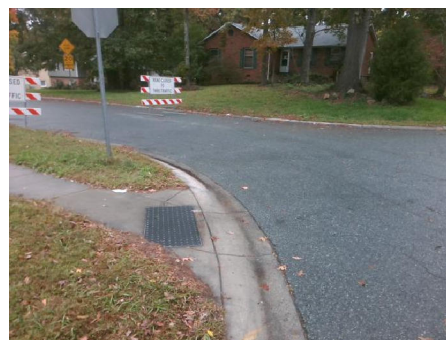
Not Found, R304.5.1

Compliance	Description	Data	Compliance	Description	Data
N/A	Ramp Length (in)	28.0	Yes	BlendTrans Slope (%)	2.6
No	Ramp Width (in)	45.5	Yes	BlendTrans XSlope (%)	1.7
N/A	Flare Type LT	N/A	N/A	Flare Type RT	N/A
N/A	Flare Slope LT (%)	N/A	N/A	Flare Slope RT (%)	N/A
N/A	Flare Traversable LT?	N/A	N/A	Flare Traversable RT?	N/A
N/A	Landing Length (in)	N/A	N/A	DWS Provided?	N/A
N/A	Landing Width (in)	N/A	N/A	DWS Contrast?	N/A
N/A	Landing Slope (%)	N/A	N/A	DWS Length (in)	N/A
N/A	Landing X Slope (%)	N/A	N/A	DWS Full Width?	N/A
N/A	Landing Curb? (Y/N)	N/A	N/A	DWS Offset (in)	N/A
N/A	Shared Landing?	N/A			
N/A	Gutter Ponding?	N/A	N/A	Gutter Slope (%)	N/A
N/A	Gutter Lip Ht (in)	N/A	N/A	Gutter X Slope (%)	N/A
N/A	Painted X Walk1?	No	N/A	Painted X Walk2?	No
	X Walk 1 Direction	To E		X Walk 2 Direction	To N
	X Walk 1 Width (in)	N/A		X Walk 2 Width (in)	N/A
	X Walk 1 Slope (%)	4.2		X Walk 2 Slope (%)	2.3
	X Walk 1 X Slope (%)	2.7		X Walk 2 X Slope (%)	2.8

N/A	Ramp inside XWalk1?	N/A	N/A	Ramp inside XWalk2?	N/A
	Road Slope (%)	1.5		Clear Space?	N/A
	Road X Slope (%)	3.1	N/A	Clear Space to XWalk (in)	N/A
N/A	Any Obstructions?	N/A	N/A	Storm Grate/Utility Hazard?	N/A
	Obstruction Type			Storm Grate/Utility Type	
		N/A			N/A
			Yes	Surface Condition? (G/P)	Good
			No	Curb Slope (%)	13.8

Remove & Replace Curb Ramp With Two New Directional Ramps or Equivalent.
