Intersection ID: 31482	Main Street: COMMACK_DR	Cross Street: FLAGLER_LN	Location:	N
ADA ID: F8F870A18081	Ramp Type: PerpDiag	Initial Pass/Fail: Fail	Overall Compliance: No	Severity Score: 21.25

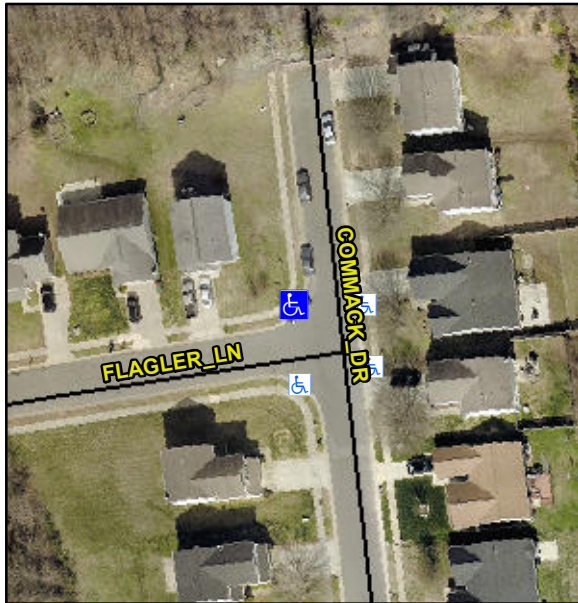
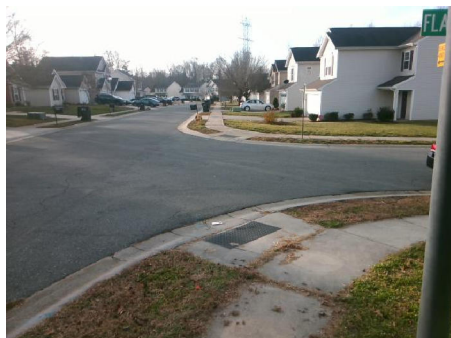
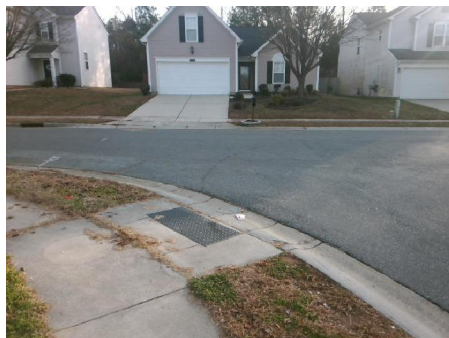
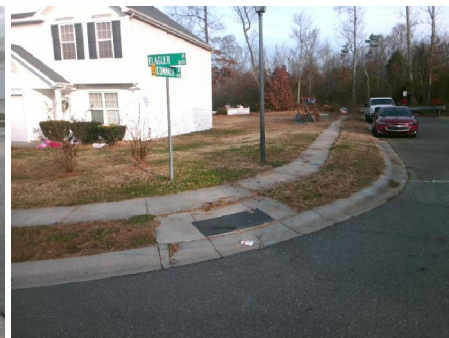
**Not Found, R304.5.1, R304.5.3**

Compliance	Description	Data	Compliance	Description	Data
N/A	Ramp Length (in)	47.0	Yes	Ramp Slope (%)	6.3
No	Ramp Width (in)	37.5	No	Ramp XSlope (%)	5.1
N/A	Flare Type LT	N/A	N/A	Flare Type RT	N/A
N/A	Flare Slope LT (%)	N/A	N/A	Flare Slope RT (%)	N/A
N/A	Flare Traversable LT?	N/A	N/A	Flare Traversable RT?	N/A
N/A	Landing Length (in)	N/A	N/A	DWS Provided?	N/A
N/A	Landing Width (in)	N/A	N/A	DWS Contrast?	N/A
N/A	Landing Slope (%)	N/A	N/A	DWS Length (in)	N/A
N/A	Landing X Slope (%)	N/A	N/A	DWS Full Width?	N/A
N/A	Landing Curb? (Y/N)	N/A	N/A	DWS Offset (in)	N/A
N/A	Shared Landing?	N/A			
N/A	Gutter Ponding?	N/A	N/A	Gutter Slope (%)	N/A
N/A	Gutter Lip Ht (in)	N/A	N/A	Gutter X Slope (%)	N/A
N/A	Painted X Walk1?	No	N/A	Painted X Walk2?	No
	X Walk 1 Direction	To S		X Walk 2 Direction	To E
N/A	X Walk 1 Width (in)	N/A	N/A	X Walk 2 Width (in)	N/A
	X Walk 1 Slope (%)	4.0		X Walk 2 Slope (%)	3.8
	X Walk 1 X Slope (%)	0.1		X Walk 2 X Slope (%)	1.4

N/A	Ramp inside XWalk1?	N/A	N/A	Ramp inside XWalk2?	N/A
	Road Slope (%)	4.6	N/A	Clear Space?	N/A
	Road X Slope (%)	2.2	N/A	Clear Space to XWalk (in)	N/A
N/A	Any Obstructions?	N/A	N/A	Storm Grate/Utility Hazard?	N/A
	Obstruction Type			Storm Grate/Utility Type	
		N/A			N/A
			Yes	Surface Condition? (G/P)	Good

**Remove & Replace Curb Ramp With Two New Directional Ramps or Equivalent.**
