# Access Compliance Report

## Public Rights-of-Way

### (Curb Ramps)

Intersection ID: 32319	Main Street: ARDREY_KELL_RD	Cross Street: BRIDGEVIEW_LN	Location: NE
ADA ID: F8FCB119A265	Ramp Type: Perp	Initial Pass/Fail: Fail	Overall Compliance: No
			Severity Score: 58.75

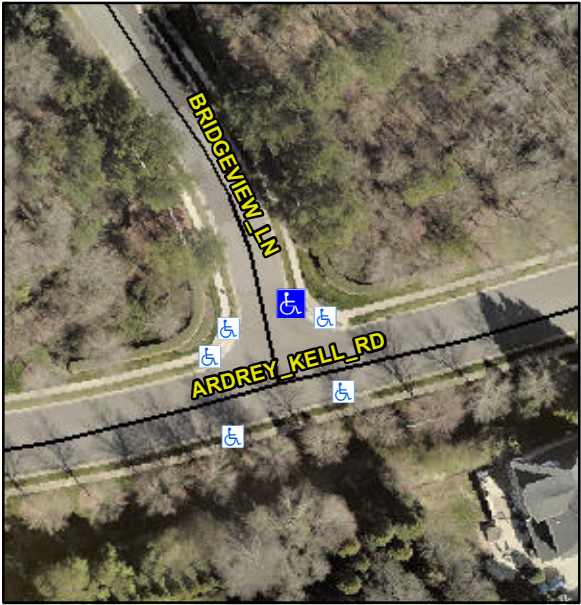
Possible Solutions:		<b>Compliance</b>	<b>Description</b>	<b>Data</b>	<b>Compliance</b>
	<b>Remove &amp; Replace Entire Ramp.</b>		<b>No</b>	Ramp Length (in)	<b>49.0</b>	<b>No</b>
			<b>No</b>	Ramp Width (in)	<b>37.5</b>	<b>No</b>
			<b>N/A</b>	Flare Type LT	<b>N/A</b>	<b>N/A</b>
			<b>N/A</b>	Flare Slope LT (%)	<b>N/A</b>	<b>N/A</b>
			<b>N/A</b>	Flare Traversable LT?	<b>N/A</b>	<b>N/A</b>
			<b>N/A</b>	Landing Length (in)	<b>N/A</b>	<b>N/A</b>
			<b>N/A</b>	Landing Width (in)	<b>N/A</b>	<b>N/A</b>
			<b>N/A</b>	Landing Slope (%)	<b>N/A</b>	<b>N/A</b>
			<b>N/A</b>	Landing X Slope (%)	<b>N/A</b>	<b>N/A</b>
<p>Surveyor Notes:</p> <p><b>N/A</b></p> <p>PROW/ADA:</p> <p><b>Not Found, R304.5.1, R304.2.2, R304.5.3</b></p>			<b>N/A</b>	Flare Type RT	<b>N/A</b>	<b>N/A</b>
			<b>N/A</b>	Flare Slope RT (%)	<b>N/A</b>	<b>N/A</b>

<b>N/A</b>	Flare Traversable RT?	<b>N/A</b>	<b>N/A</b>
			<b>N/A</b>	DWS Provided?	<b>N/A</b>	<b>N/A</b>
			<b>N/A</b>	DWS Contrast?	<b>N/A</b>	<b>N/A</b>
			<b>N/A</b>	DWS Length (in)	<b>N/A</b>	<b>N/A</b>
			<b>N/A</b>	DWS Full Width?	<b>N/A</b>	<b>N/A</b>
			<b>N/A</b>	DWS Offset (in)	<b>N/A</b>	<b>N/A</b>
			<b>N/A</b>	Gutter Ponding?	<b>N/A</b>	<b>N/A</b>
			<b>N/A</b>	Gutter Lip Ht (in)	<b>N/A</b>	<b>N/A</b>
<p>Total Cost:</p> <p><b>\$ 1850.00</b></p>			<b>No</b>	Painted X Walk1?	<b>N/A</b>	<b>N/A</b>
			<b>To W</b>	X Walk 1 Direction	<b>N/A</b>	<b>N/A</b>
			<b>N/A</b>	X Walk 1 Width (in)	<b>N/A</b>	<b>N/A</b>
			<b>0.3</b>	X Walk 1 Slope (%)	<b>N/A</b>	<b>N/A</b>
			<b>5.9</b>	X Walk 1 X Slope (%)	<b>N/A</b>	<b>N/A</b>
			<b>N/A</b>	Ramp inside XWalk1?	<b>N/A</b>	<b>N/A</b>
			<b>N/A</b>	Road Slope (%)	<b>N/A</b>	<b>N/A</b>
			<b>N/A</b>	Road X Slope (%)	<b>N/A</b>	<b>N/A</b>
			<b>N/A</b>	Any Obstructions?	<b>N/A</b>	<b>N/A</b>

Obstruction Type	<b>N/A</b>	<b>N/A</b>
			<b>N/A</b>	Storm Grate/Utility Hazard?	<b>N/A</b>	<b>N/A</b>
			<b>N/A</b>	Storm Grate/Utility Type	<b>N/A</b>	<b>N/A</b>
			<b>Yes</b>	Surface Condition? (G/P)	<b>Good</b>	<b>Good</b>
