# Access Compliance Report

## Public Rights-of-Way

### (Curb Ramps)

| Intersection ID: 8569 | Main Street: PENNY_WY | Cross Street: W_SUGAR_CREEK_RD | Location: NE |

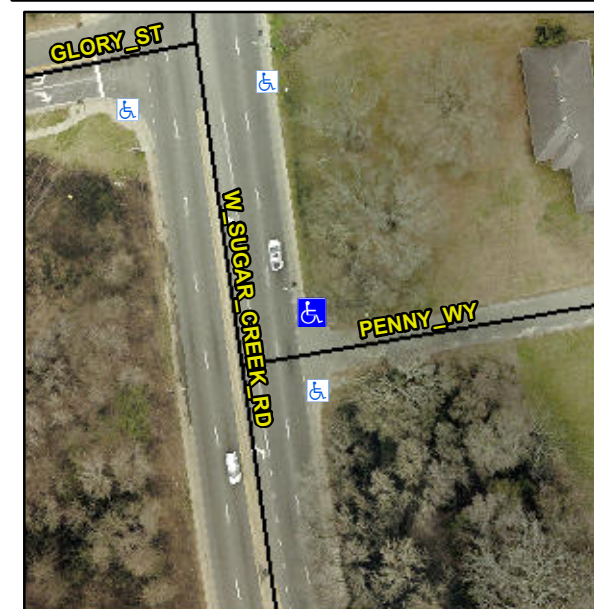
**Not Found, R304.5.3, R304.2.1, R304.2.2-Perp, R304.3.2-Para**

| Compliance | Description | Data | Compliance | Description | Data |
|---|---|---|---|---|---|
| Yes | Ramp Width (in) | 48.0 | No | Ramp XSlope (%) | 3.8 |
| No | Landing Length (in) | 26.0 | Yes | DWS Provided? | Yes |
| No | Landing Slope (%) | 2.9 | Yes | DWS Length (in) | 24.5 |
| No | Landing X Slope (%) | 4.4 | Yes | DWS Full Width? | Yes |
| Yes | Gutter Lip Ht (in) | 0.0 | No | Gutter X Slope (%) | 5.2 |

**Remove & Replace Curb Ramp With Two New Directional Ramps or Equivalent. Remove & Replace Gutter.**

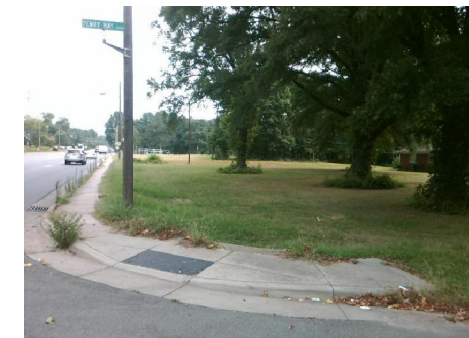
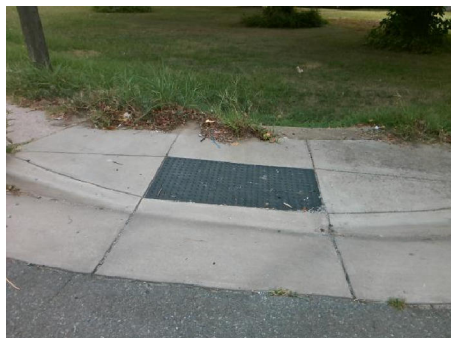
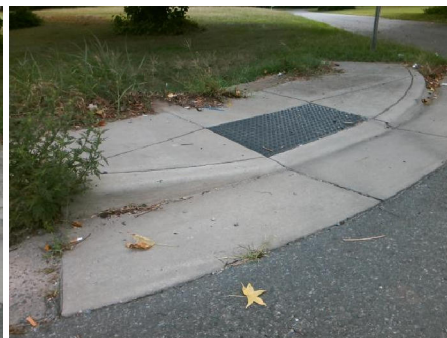
| Compliance | Description | Data | Compliance | Description | Data |
|---|---|---|---|---|---|
| | | | Yes | Surface Condition? (G/P) | Good |
