# Access Compliance Report

## Public Rights-of-Way (Curb Ramps)

| Intersection ID: 14547 | Main Street: EAST_BV | Cross Street: SPRINGDALE_AV | Location: SW |
| ADA ID: F8FF2EBB9DE6 | Ramp Type: BlendTrans1 | Initial Pass/Fail: Pass | Overall Compliance: No |

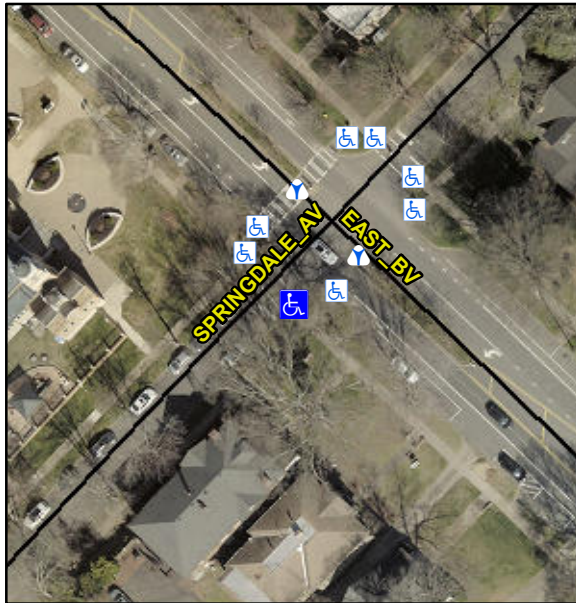
| Compliance | Description | Data | Compliance | Description | Data |
|---|---|---|---|---|---|
| N/A | Landing Curb? (Y/N) | No | No | DWS Offset (in) | 6.0 |
| Yes | Gutter Lip Ht (in) | 0.0 | No | Gutter X Slope (%) | 3.4 |

**Remove & Replace Detectable Warning System. Remove & Replace Gutter.**

**R305.2, R304.5.3**
