Access Compliance Report

Public Rights-of-Way

(Curb Ramps)

Intersection ID: 8879	Main Street: LAMBETH_DR	Cross Street: N_TRYON_ST	Location: NE
ADA ID: F9042ABF7A8B	Ramp Type: ParaDiag	Initial Pass/Fail: Fail	Overall Compliance: No
			Severity Score: 13.75

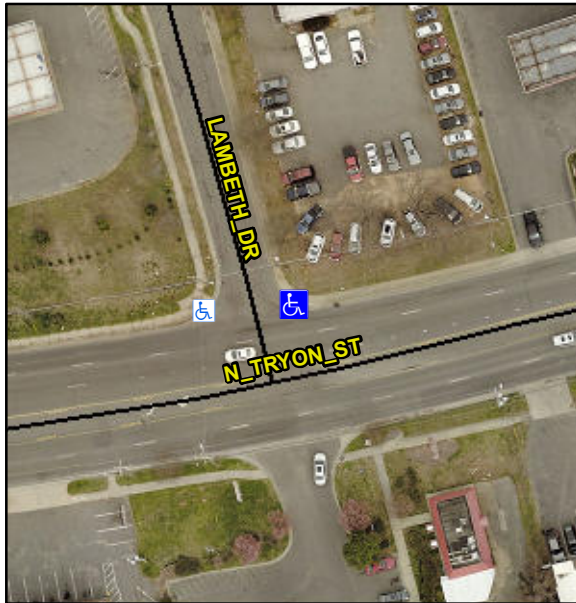
LT RP < 5%

R304.3.2, R304.5.3

Compliance	Description	Data	Compliance	Description	Data
N/A	Ramp Length LT (in)	54.5	N/A	Ramp Length RT (in)	49.0
Yes	Ramp Width LT (in)	54.0	Yes	Ramp Width RT (in)	59.0
Yes	Ramp Slope LT (%)	2.8	No	Ramp Slope RT (%)	10.1
Yes	Ramp XSlope LT (%)	1.9	No	Ramp XSlope RT (%)	2.1
N/A	Landing Length (in)	N/A	N/A	DWS Provided?	N/A
N/A	Landing Width (in)	N/A	N/A	DWS Contrast?	N/A
N/A	Landing Slope (%)	N/A	N/A	DWS Length (in)	N/A
N/A	Landing X Slope (%)	N/A	N/A	DWS Full Width?	N/A
N/A	Landing Curb? (Y/N)	N/A	N/A	DWS Offset (in)	N/A
N/A	Shared Landing?	N/A			
N/A	Gutter Ponding?	N/A	N/A	Gutter Slope (%)	N/A
N/A	Gutter Lip Ht (in)	N/A	N/A	Gutter X Slope (%)	N/A
N/A	Painted X Walk1?	No	N/A	Painted X Walk2?	No
	X Walk 1 Direction	To W		X Walk 2 Direction	To SE
N/A	X Walk 1 Width (in)	N/A	N/A	X Walk 2 Width (in)	N/A
	X Walk 1 Slope (%)	0.9		X Walk 2 Slope (%)	3.2
	X Walk 1 X Slope (%)	3.2		X Walk 2 X Slope (%)	1.0
N/A	Ramp inside XWalk1?	N/A	N/A	Ramp inside XWalk2?	N/A

Road Slope (%)	1.9	N/A	Clear Space?	N/A
	Road X Slope (%)	3.3	N/A	Clear Space to XWalk (in)	N/A
N/A	Any Obstructions?	N/A	N/A	Storm Grate/Utility Hazard?	N/A
	Obstruction Type			Storm Grate/Utility Type	
		N/A			N/A
			Yes	Surface Condition? (G/P)	Good
			N/A	Curb Slope (%)	24.3

Possible Solutions:

Remove & Replace Curb Ramp With Two New Directional Ramps or Equivalent.
