# Access Compliance Report

## Public Rights-of-Way

### (Curb Ramps)

Intersection ID: 11231	Main Street: W_4TH_ST_EXT	Cross Street: WALNUT_AV	Location: S
ADA ID: F90892F7B3D7	Ramp Type: Directional1	Initial Pass/Fail: Pass	Overall Compliance: No
Severity Score: 0.25			
Codes/Mitigation Info/Possible Solution		Field Measurements/Component Compliance

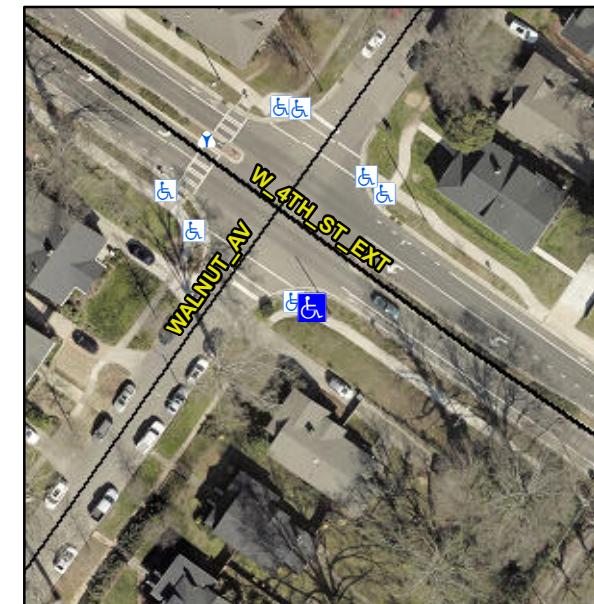
Compliance	Description	Data	Compliance	Description	Data
N/A	Ramp Length (in)	98.0	Yes	Grade Break?	Yes
Yes	Ramp Width (in)	68.0	Yes	Grade Break Slope (%)	3.7
Yes	Ramp Slope (%)	3.3	Yes	Grade Break XSlope (%)	1.6
Yes	Ramp XSlope (%)	2.8			
Yes	Flare Type LT	N/A	Yes	Flare Type RT	N/A
N/A	Flare Slope LT (%)	N/A	N/A	Flare Slope RT (%)	N/A
N/A	Flare Traversable LT?	No	N/A	Flare Traversable RT?	No
Yes	Landing Length (in)	71.0	Yes	DWS Provided?	Yes
Yes	Landing Width (in)	68.0	Yes	DWS Contrast?	Yes
Yes	Landing Slope (%)	0.1	Yes	DWS Length (in)	24.0
Yes	Landing X Slope (%)	0.3	Yes	DWS Full Width?	Yes
N/A	Landing Curb? (Y/N)	No	Yes	DWS Offset LT (in)	27.0
N/A	Shared Landing?	Yes	Yes	DWS Offset RT (in)	2.0
Yes	Gutter Ponding?	No	Yes	Gutter Slope (%)	2.3
Yes	Gutter Lip Ht (in)	0.0	No	Gutter X Slope (%)	4.0
N/A	Painted X Walk1?	No		Road Slope (%)	5.1
	X Walk 1 Direction	To NE		Road X Slope (%)	3.4
	X Walk 1 Width (in)	N/A		Clear Space?	Yes

X Walk 1 Slope (%)	5.1	N/A	Clear Space to XWalk (in)	N/A
	X Walk 1 X Slope (%)	3.4	Yes	Storm Grate/Utility Hazard?	No
N/A	Ramp inside XWalk1?	N/A		Storm Grate/Utility Type	
Yes	Any Obstructions?	No			N/A
	Obstruction Type		Yes	Surface Condition? (G/P)	Good
			N/A	Curb Slope (%)	2.9

Possible Solutions:

**Remove & Replace Gutter.**

PROW/ADA:

**R304.5.3**
