# Access Compliance Report

## Public Rights-of-Way

### (Curb Ramps)

| Intersection ID: 53012 | Main Street: BESSEMER_ST | Cross Street: BILLET_LN | Location: SE |

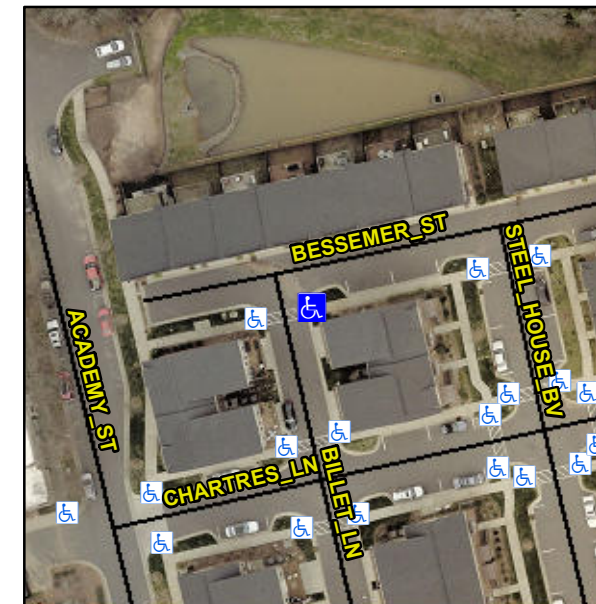
| ADA ID: F9093B1EAFF6 | Ramp Type: BlendTrans1 | Initial Pass/Fail: Fail | Overall Compliance: No |
| Severity Score: 1.25 | | | |

**Not Found, R304.5.3**

| Compliance | Description | Data | Compliance | Description | Data |
|---|---|---|---|---|---|
| Yes | Ramp Width (in) | 65.0 | No | BlendTrans XSlope (%) | 2.4 |

**Remove & Replace Curb Ramp With Two New Directional Ramps or Equivalent.**

Total Cost: \$ 3200.00

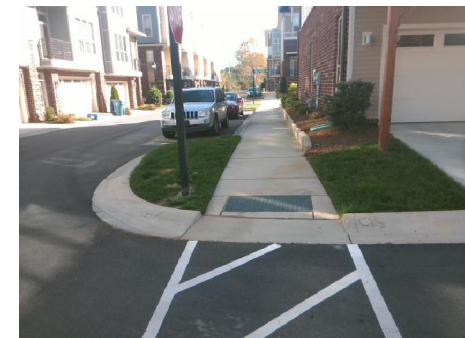
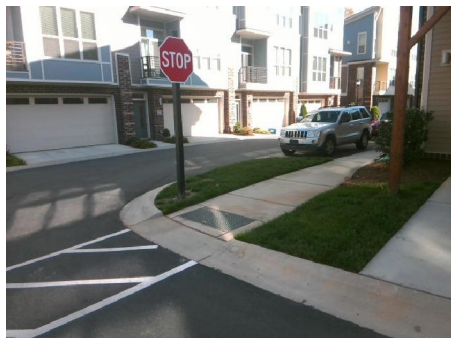
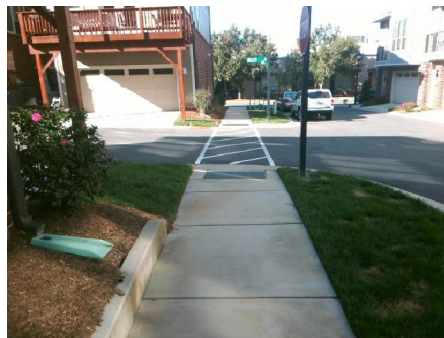
| Compliance | Description | Data | Compliance | Description | Data |
|---|---|---|---|---|---|
| N/A | Ramp Length (in) | 120.0 | Yes | BlendTrans Slope (%) | 4.3 |
| | | | No | Curb Slope (%) | 9.4 |
