Access Compliance Report

Public Rights-of-Way

(Curb Ramps)

Intersection ID: 10033982	Main Street: PARK_RD	Cross Street: N/A	Location: NW
ADA ID: F910B0DD636C	Ramp Type: PerpDiag	Initial Pass/Fail: Fail	Overall Compliance: No
		Severity Score: 12.5

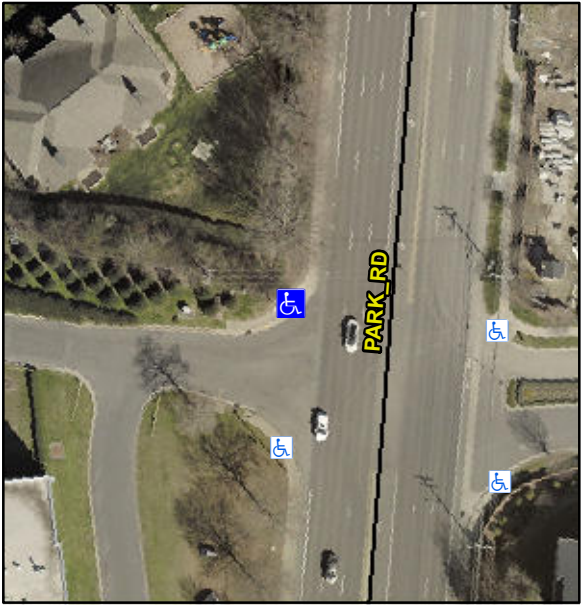
Possible Solutions:		Compliance	Description	Data	
	Remove & Replace Curb Ramp With Two New Directional Ramps or Equivalent.		N/A	Ramp Length (in)	60.0	No
			Yes	Ramp Width (in)	56.0	Yes
			N/A	Flare Type LT	N/A	N/A
			N/A	Flare Slope LT (%)	N/A	N/A
			N/A	Flare Traversable LT?	N/A	N/A
			N/A	Landing Length (in)	N/A	N/A
			N/A	Landing Width (in)	N/A	N/A
			N/A	Landing Slope (%)	N/A	N/A
			N/A	Landing X Slope (%)	N/A	N/A
			N/A	Landing Curb? (Y/N)	N/A	N/A
			N/A	Shared Landing?	N/A	
			N/A	Gutter Ponding?	N/A	N/A
			N/A	Gutter Lip Ht (in)	N/A	N/A
			N/A	Painted X Walk1?	No	N/A
				X Walk 1 Direction	To SW	X Walk 2 Direction
			N/A	X Walk 1 Width (in)	N/A	N/A
				X Walk 1 Slope (%)	2.7	X Walk 2 Slope (%)
				X Walk 1 X Slope (%)	2.0	X Walk 2 X Slope (%)
			N/A	Ramp inside XWalk1?	N/A	N/A
<p>Surveyor Notes:</p> <p>N/A</p> <p>PROW/ADA:</p> <p>Not Found, R304.2.2</p>

Road Slope (%)	0.7	N/A
				Road X Slope (%)	0.5	N/A
			N/A	Any Obstructions?	N/A	N/A
				Obstruction Type		
					N/A	N/A
			Yes	Surface Condition? (G/P)		Good
