Access Compliance Report

Public Rights-of-Way

(Curb Ramps)

Intersection ID: 7305	Main Street: BEATTIES_FORD_RD	Cross Street: LYNCHESTER_PL	Location: NW
ADA ID: F9164C500C07	Ramp Type: ParaDiag	Initial Pass/Fail: Pass	Overall Compliance: No
Severity Score: 0.25			
Codes/Mitigation Info/Possible Solution		Field Measurements/Component Compliance

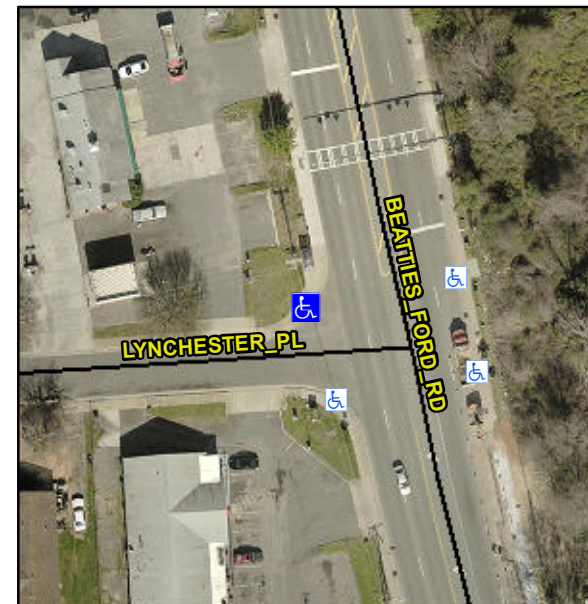
Compliance	Description	Data	Compliance	Description	Data
N/A	Ramp Length LT (in)	53.0	N/A	Ramp Length RT (in)	36.0
Yes	Ramp Width LT (in)	72.0	Yes	Ramp Width RT (in)	72.0
Yes	Ramp Slope LT (%)	7.0	Yes	Ramp Slope RT (%)	5.3
Yes	Ramp XSlope LT (%)	0.1	No	Ramp XSlope RT (%)	3.1
Yes	Landing Length (in)	83.0	Yes	DWS Provided?	Yes
No	Landing Width (in)	46.0	Yes	DWS Contrast?	Yes
Yes	Landing Slope (%)	1.1	Yes	DWS Length (in)	24.0
Yes	Landing X Slope (%)	1.6	Yes	DWS Full Width?	Yes
N/A	Landing Curb? (Y/N)	No	Yes	DWS Offset (in)	1.0
N/A	Shared Landing?	No			
Yes	Gutter Ponding?	No	Yes	Gutter Slope (%)	2.7
Yes	Gutter Lip Ht (in)	0.0	Yes	Gutter X Slope (%)	0.7
N/A	Painted X Walk1?	No	N/A	Painted X Walk2?	No
	X Walk 1 Direction	To S		X Walk 2 Direction	To E
N/A	X Walk 1 Width (in)	N/A	N/A	X Walk 2 Width (in)	N/A
	X Walk 1 Slope (%)	4.3		X Walk 2 Slope (%)	1.8
	X Walk 1 X Slope (%)	2.1		X Walk 2 X Slope (%)	1.8
N/A	Ramp inside XWalk1?	N/A	N/A	Ramp inside XWalk2?	N/A

Road Slope (%)	3.5	N/A	Clear Space?	Yes
	Road X Slope (%)	3.9	N/A	Clear Space to XWalk (in)	N/A
Yes	Any Obstructions?	No	Yes	Storm Grate/Utility Hazard?	No
	Obstruction Type			Storm Grate/Utility Type	
		N/A			N/A
			Yes	Surface Condition? (G/P)	Good
			N/A	Curb Slope (%)	14.5

Possible Solutions:

Remove & Replace Curb Ramp With Two New Directional Ramps or Equivalent.

R304.5.3, R304.2.1

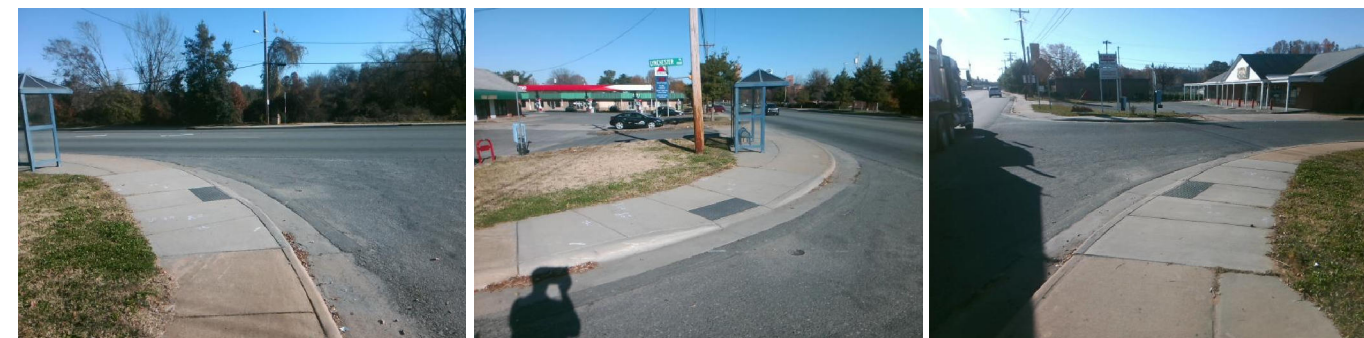
Street 1 Name LYNCHESTER PL
 Stop Condition-Street 1 StopSign
 Street 2 Name BEATTIES FORD RD
 Stop Condition-Street 2 None
