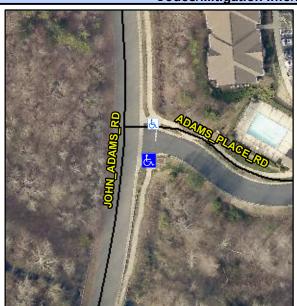
| Field Measurements/Component Compliance | | | | | | |
|---|---|---|---|---|---|---|
| Comp | liance Description | Data | Comp | liance | Description | Data |
| N/A | Ramp Length (in) | 73.0 | No | Ramp | Slope (%) | 20.0 |

Street 1 Name ADAMS PLACE RD
Stop Condition-Street 2 StopSign
Street 2 Name N/A
Stop Condition-Street 1 N/A
