Access Compliance Report

Public Rights-of-Way

(Curb Ramps)

Intersection ID: 5832	Main Street: N_TRYON_ST	Cross Street: KEN_HOFFMAN_DR	Location:	N
ADA ID: F91F218611F1	Ramp Type: Combination2	Initial Pass/Fail: Fail	Overall Compliance: No	Severity Score: 12.5

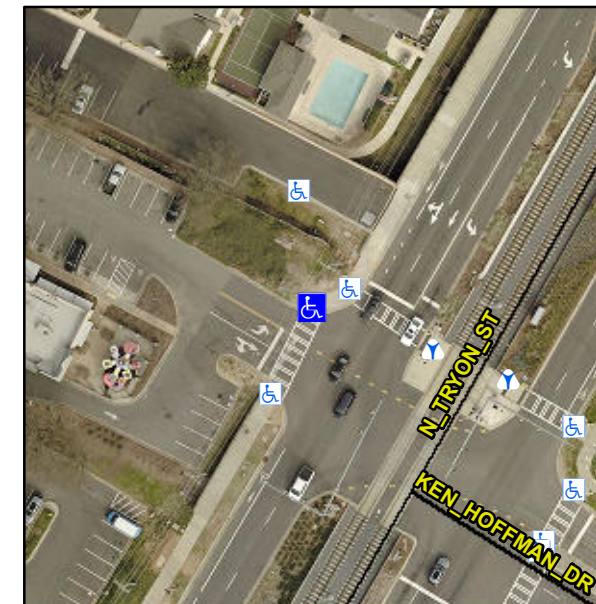
Compliance	Description	Data	Compliance	Description	Data
N/A	Ramp Length LT (in)	N/A	N/A	Ramp Length RT (in)	76.0
N/A	Ramp Width LT (in)	N/A	Yes	Ramp Width RT (in)	70.5
N/A	Ramp Slope LT (%)	N/A	No	Ramp Slope RT (%)	9.7
N/A	Ramp XSlope LT (%)	N/A	Yes	Ramp XSlope RT (%)	1.3
N/A	Ramp Length (in)	25.0	Yes	Ramp Slope (%)	6.0
No	Ramp Width (in)	47.0	Yes	Ramp XSlope (%)	1.3
N/A	Flare Type LT	N/A	N/A	Flare Type RT	N/A
N/A	Flare Slope LT (%)	N/A	N/A	Flare Slope RT (%)	N/A
N/A	Flare Traversable LT?	N/A	N/A	Flare Traversable RT?	N/A
N/A	Landing Length (in)	N/A	N/A	DWS Provided?	N/A
N/A	Landing Width (in)	N/A	N/A	DWS Contrast?	N/A
N/A	Landing Slope (%)	N/A	N/A	DWS Length (in)	N/A
N/A	Landing X Slope (%)	N/A	N/A	DWS Full Width?	N/A
N/A	Landing Curb? (Y/N)	N/A	N/A	DWS Offset (in)	N/A
N/A	Shared Landing?	N/A			
N/A	Gutter Ponding?	N/A	N/A	Gutter Slope (%)	N/A
N/A	Gutter Lip Ht (in)	N/A	N/A	Gutter X Slope (%)	N/A
N/A	Painted X Walk1?	No	N/A	Painted X Walk2?	N/A

X Walk 1 Direction	To SW		X Walk 2 Direction	N/A
	X Walk 1 Width (in)	N/A		X Walk 2 Width (in)	N/A
	X Walk 1 Slope (%)	7.3		X Walk 2 Slope (%)	N/A
	X Walk 1 X Slope (%)	3.6		X Walk 2 X Slope (%)	N/A
N/A	Ramp inside XWalk1?	N/A	N/A	Ramp inside XWalk2?	N/A
	Road Slope (%)	N/A		Clear Space?	N/A
	Road X Slope (%)	N/A	N/A	Clear Space to XWalk (in)	N/A
			N/A	Any Obstruction?	N/A
				Obstruction Type	N/A
			N/A	Storm Grate/Utility Hazard?	N/A
				Storm Grate/Utility Type	N/A
			Yes	Surface Condition? (G/P)	Good
				Curb Slope (%)	N/A

Remove & Replace Entire Ramp.
