Access Compliance Report

Public Rights-of-Way

(Curb Ramps)

Intersection ID: 7169	Main Street: MILBURN_CT	Cross Street: TILDEN_RD	Location:	S
ADA ID: F9280C80955A	Ramp Type: Perp	Initial Pass/Fail: Fail	Overall Compliance: No	Severity Score: 8.75
Codes/Mitigation Info/Possible Solution		Field Measurements/Component Compliance

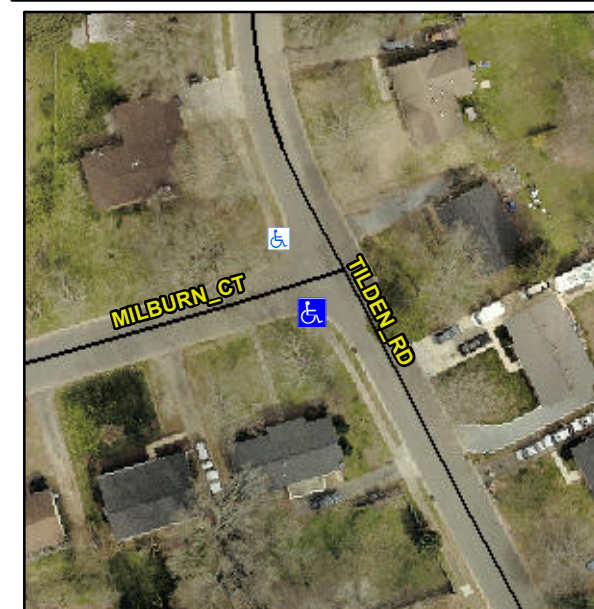
Not Found, R304.5.1

Compliance	Description	Data	Compliance	Description	Data
N/A	Ramp Length (in)	48.0	Yes	Ramp Slope (%)	5.1
No	Ramp Width (in)	39.0	Yes	Ramp XSlope (%)	0.1
N/A	Flare Type LT	N/A	N/A	Flare Type RT	N/A
N/A	Flare Slope LT (%)	N/A	N/A	Flare Slope RT (%)	N/A
N/A	Flare Traversable LT?	N/A	N/A	Flare Traversable RT?	N/A
N/A	Landing Length (in)	N/A	N/A	DWS Provided?	N/A
N/A	Landing Width (in)	N/A	N/A	DWS Contrast?	N/A
N/A	Landing Slope (%)	N/A	N/A	DWS Length (in)	N/A
N/A	Landing X Slope (%)	N/A	N/A	DWS Full Width?	N/A
N/A	Landing Curb? (Y/N)	N/A	N/A	DWS Offset (in)	N/A
N/A	Shared Landing?	N/A			
N/A	Gutter Ponding?	N/A	N/A	Gutter Slope (%)	N/A
N/A	Gutter Lip Ht (in)	N/A	N/A	Gutter X Slope (%)	N/A
N/A	Painted X Walk1?	No	N/A	Painted X Walk2?	N/A
	X Walk 1 Direction	To N		X Walk 2 Direction	N/A
N/A	X Walk 1 Width (in)	N/A	N/A	X Walk 2 Width (in)	N/A
	X Walk 1 Slope (%)	3.0		X Walk 2 Slope (%)	N/A
	X Walk 1 X Slope (%)	1.1		X Walk 2 X Slope (%)	N/A

N/A	Ramp inside XWalk1?	N/A	N/A	Ramp inside XWalk2?	N/A
	Road Slope (%)	N/A	N/A	Clear Space?	N/A
	Road X Slope (%)	N/A	N/A	Clear Space to XWalk (in)	N/A
N/A	Any Obstructions?	N/A	N/A	Storm Grate/Utility Hazard?	N/A
	Obstruction Type			Storm Grate/Utility Type	
		N/A			N/A
			Yes	Surface Condition? (G/P)	Good

Remove & Replace Entire Ramp.
