# Access Compliance Report

## Public Rights-of-Way

### (Curb Ramps)

Intersection ID: 46686	Main Street: GOLDFIELDS_DR	Cross Street: AYERS_ORCHARD_WY	Location: NE
ADA ID: F92FB46351D4	Ramp Type: PerpDiag	Initial Pass/Fail: Fail	Overall Compliance: No
Severity Score: 13.75			
Codes/Mitigation Info/Possible Solution		Field Measurements/Component Compliance

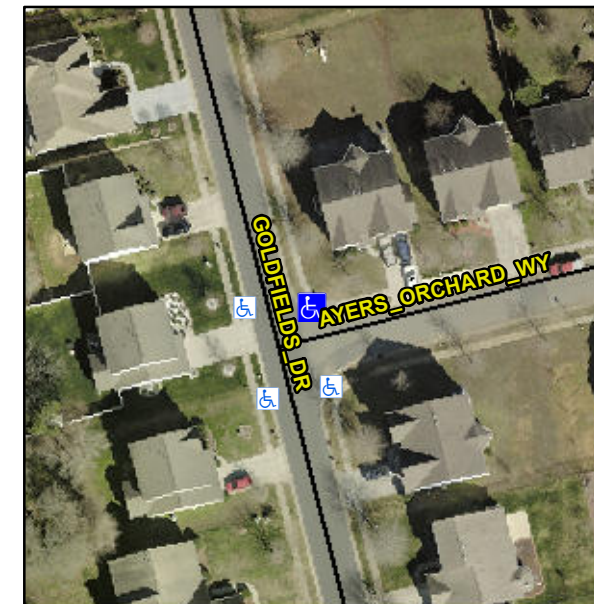
**Not Found, R304.2.2, R304.5.3**

Compliance	Description	Data	Compliance	Description	Data
N/A	Ramp Length (in)	45.0	No	Ramp Slope (%)	8.8
Yes	Ramp Width (in)	48.0	No	Ramp XSlope (%)	3.3
N/A	Flare Type LT	N/A	N/A	Flare Type RT	N/A
N/A	Flare Slope LT (%)	N/A	N/A	Flare Slope RT (%)	N/A
N/A	Flare Traversable LT?	N/A	N/A	Flare Traversable RT?	N/A
N/A	Landing Length (in)	N/A	N/A	DWS Provided?	N/A
N/A	Landing Width (in)	N/A	N/A	DWS Contrast?	N/A
N/A	Landing Slope (%)	N/A	N/A	DWS Length (in)	N/A
N/A	Landing X Slope (%)	N/A	N/A	DWS Full Width?	N/A
N/A	Landing Curb? (Y/N)	N/A	N/A	DWS Offset (in)	N/A
N/A	Shared Landing?	N/A			
N/A	Gutter Ponding?	N/A	N/A	Gutter Slope (%)	N/A
N/A	Gutter Lip Ht (in)	N/A	N/A	Gutter X Slope (%)	N/A
N/A	Painted X Walk1?	No	N/A	Painted X Walk2?	No
	X Walk 1 Direction	To W		X Walk 2 Direction	To S
N/A	X Walk 1 Width (in)	N/A	N/A	X Walk 2 Width (in)	N/A
	X Walk 1 Slope (%)	1.4		X Walk 2 Slope (%)	6.0
	X Walk 1 X Slope (%)	3.6		X Walk 2 X Slope (%)	0.2

N/A	Ramp inside XWalk1?	N/A	N/A	Ramp inside XWalk2?	N/A
	Road Slope (%)	3.2	N/A	Clear Space?	N/A
	Road X Slope (%)	1.4	N/A	Clear Space to XWalk (in)	N/A
N/A	Any Obstructions?	N/A	N/A	Storm Grate/Utility Hazard?	N/A
	Obstruction Type			Storm Grate/Utility Type	
		N/A			N/A
		Yes		Surface Condition? (G/P)	Good

**Remove & Replace Curb Ramp With Two New Directional Ramps or Equivalent.**
