Access Compliance Report

Public Rights-of-Way

(Curb Ramps)

Intersection ID: 8496	Main Street: PENNSYLVANIA_AV	Cross Street: VENICE_ST	Location: SW
ADA ID: F945D2473D24	Ramp Type: Perp	Initial Pass/Fail: Fail	Overall Compliance: No
Severity Score: 13.75			
Codes/Mitigation Info/Possible Solution		Field Measurements/Component Compliance

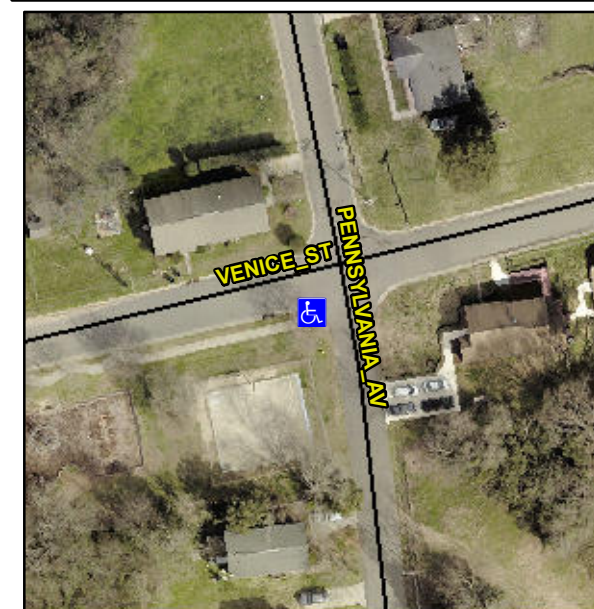
Not Found, R304.2.2, R304.5.3

Compliance	Description	Data	Compliance	Description	Data
N/A	Ramp Length (in)	67.0	No	Ramp Slope (%)	10.4
Yes	Ramp Width (in)	48.2	No	Ramp XSlope (%)	2.7
N/A	Flare Type LT	N/A	N/A	Flare Type RT	N/A
N/A	Flare Slope LT (%)	N/A	N/A	Flare Slope RT (%)	N/A
N/A	Flare Traversable LT?	N/A	N/A	Flare Traversable RT?	N/A
N/A	Landing Length (in)	N/A	N/A	DWS Provided?	N/A
N/A	Landing Width (in)	N/A	N/A	DWS Contrast?	N/A
N/A	Landing Slope (%)	N/A	N/A	DWS Length (in)	N/A
N/A	Landing X Slope (%)	N/A	N/A	DWS Full Width?	N/A
N/A	Landing Curb? (Y/N)	N/A	N/A	DWS Offset (in)	N/A
N/A	Shared Landing?	N/A			
N/A	Gutter Ponding?	N/A	N/A	Gutter Slope (%)	N/A
N/A	Gutter Lip Ht (in)	N/A	N/A	Gutter X Slope (%)	N/A
N/A	Painted X Walk1?	No	N/A	Painted X Walk2?	N/A
	X Walk 1 Direction	To E		X Walk 2 Direction	N/A
N/A	X Walk 1 Width (in)	N/A	N/A	X Walk 2 Width (in)	N/A
	X Walk 1 Slope (%)	2.7		X Walk 2 Slope (%)	N/A
	X Walk 1 X Slope (%)	0.5		X Walk 2 X Slope (%)	N/A

N/A	Ramp inside XWalk1?	N/A	N/A	Ramp inside XWalk2?	N/A
	Road Slope (%)	0.5	N/A	Clear Space?	N/A
	Road X Slope (%)	2.7	N/A	Clear Space to XWalk (in)	N/A
N/A	Any Obstructions?	N/A	N/A	Storm Grate/Utility Hazard?	N/A
	Obstruction Type			Storm Grate/Utility Type	
		N/A			N/A
		Yes		Surface Condition? (G/P)	Good

Possible Solutions:

Remove & Replace Entire Ramp.
