# Access Compliance Report

## Public Rights-of-Way

### (Curb Ramps)

Intersection ID: 19923	Main Street: MCALPINE_PARK_DR	Cross Street: MCALPINE STATION DR	Location: SE
ADA ID: F947E78C3ED5	Ramp Type: PerpDiag	Initial Pass/Fail: Fail	Overall Compliance: No
Codes/Mitigation Info/Possible Solution		Field Measurements/Component Compliance	
Severity Score: 13.75

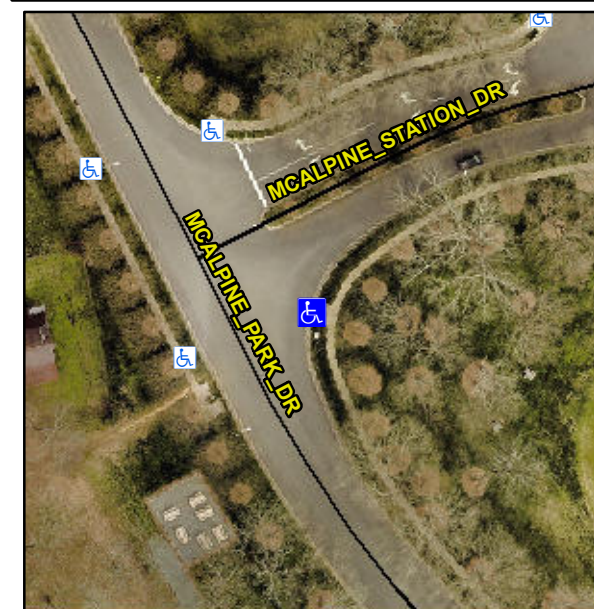
Compliance	Description	Data	Compliance	Description	Data
N/A	Ramp Length (in)	101.0	No	Ramp Slope (%)	8.9
Yes	Ramp Width (in)	48.0	No	Ramp XSlope (%)	4.6
N/A	Flare Type LT	N/A	N/A	Flare Type RT	N/A
N/A	Flare Slope LT (%)	N/A	N/A	Flare Slope RT (%)	N/A
N/A	Flare Traversable LT?	N/A	N/A	Flare Traversable RT?	N/A
N/A	Landing Length (in)	N/A	N/A	DWS Provided?	N/A
N/A	Landing Width (in)	N/A	N/A	DWS Contrast?	N/A
N/A	Landing Slope (%)	N/A	N/A	DWS Length (in)	N/A
N/A	Landing X Slope (%)	N/A	N/A	DWS Full Width?	N/A
N/A	Landing Curb? (Y/N)	N/A	N/A	DWS Offset (in)	N/A
N/A	Shared Landing?	N/A			
N/A	Gutter Ponding?	N/A	N/A	Gutter Slope (%)	N/A
N/A	Gutter Lip Ht (in)	N/A	N/A	Gutter X Slope (%)	N/A
N/A	Painted X Walk1?	No	N/A	Painted X Walk2?	No
	X Walk 1 Direction	To NE		X Walk 2 Direction	To NW
N/A	X Walk 1 Width (in)	N/A	N/A	X Walk 2 Width (in)	N/A
	X Walk 1 Slope (%)	6.8		X Walk 2 Slope (%)	5.9
	X Walk 1 X Slope (%)	4.4		X Walk 2 X Slope (%)	1.4

N/A	Ramp inside XWalk1?	N/A	N/A	Ramp inside XWalk2?	N/A
	Road Slope (%)	0.5	N/A	Clear Space?	N/A
	Road X Slope (%)	11.6	N/A	Clear Space to XWalk (in)	N/A
N/A	Any Obstructions?	N/A	N/A	Storm Grate/Utility Hazard?	N/A
	Obstruction Type			Storm Grate/Utility Type	
		N/A			N/A
		Yes		Surface Condition? (G/P)	Good

**Remove & Replace Curb Ramp With Two New Directional Ramps or Equivalent.**

**R304.2.2, R304.5.3**

Total Cost: \$ 3200.00
