# Access Compliance Report

## Public Rights-of-Way

### (Curb Ramps)

Intersection ID: 10247	Main Street: BURTON_ST	Cross Street: WHISNANT_ST	Location:	N
ADA ID: F94BC804D3ED	Ramp Type: Perp	Initial Pass/Fail: Fail	Overall Compliance: No	Severity Score: 8.75
Codes/Mitigation Info/Possible Solution		Field Measurements/Component Compliance

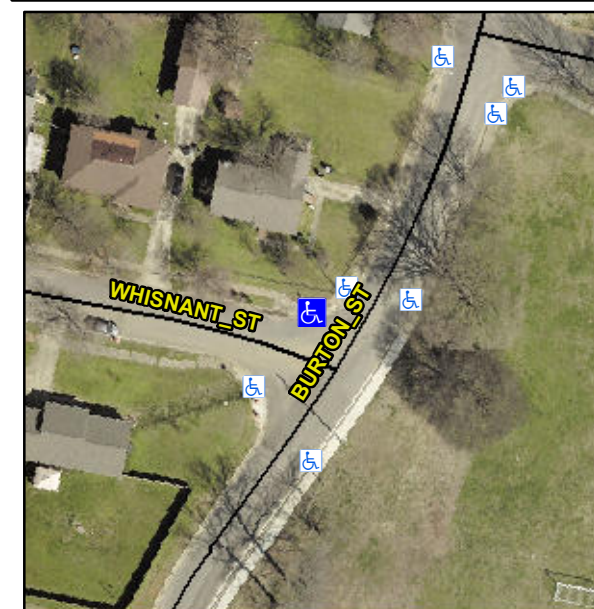
PROW/ADA:

**Not Found, R304.5.1**

Compliance	Description	Data	Compliance	Description	Data
N/A	Ramp Length (in)	67.0	Yes	Ramp Slope (%)	6.3
No	Ramp Width (in)	46.0	Yes	Ramp XSlope (%)	0.8
N/A	Flare Type LT	N/A	N/A	Flare Type RT	N/A
N/A	Flare Slope LT (%)	N/A	N/A	Flare Slope RT (%)	N/A
N/A	Flare Traversable LT?	N/A	N/A	Flare Traversable RT?	N/A
N/A	Landing Length (in)	N/A	N/A	DWS Provided?	N/A
N/A	Landing Width (in)	N/A	N/A	DWS Contrast?	N/A
N/A	Landing Slope (%)	N/A	N/A	DWS Length (in)	N/A
N/A	Landing X Slope (%)	N/A	N/A	DWS Full Width?	N/A
N/A	Landing Curb? (Y/N)	N/A	N/A	DWS Offset (in)	N/A
N/A	Shared Landing?	N/A			
N/A	Gutter Ponding?	Yes	N/A	Gutter Slope (%)	N/A
N/A	Gutter Lip Ht (in)	2.0	N/A	Gutter X Slope (%)	N/A
N/A	Painted X Walk1?	No	N/A	Painted X Walk2?	N/A
	X Walk 1 Direction	To SW		X Walk 2 Direction	N/A
N/A	X Walk 1 Width (in)	N/A	N/A	X Walk 2 Width (in)	N/A
	X Walk 1 Slope (%)	4.3		X Walk 2 Slope (%)	N/A
	X Walk 1 X Slope (%)	0.9		X Walk 2 X Slope (%)	N/A

N/A	Ramp inside XWalk1?	N/A	N/A	Ramp inside XWalk2?	N/A
	Road Slope (%)	N/A	N/A	Clear Space?	N/A
	Road X Slope (%)	N/A	N/A	Clear Space to XWalk (in)	N/A
N/A	Any Obstructions?	N/A	N/A	Storm Grate/Utility Hazard?	N/A
	Obstruction Type			Storm Grate/Utility Type	
		N/A			N/A
			Yes	Surface Condition? (G/P)	Good

Possible Solutions:

**Remove & Replace Entire Ramp.**

Total Cost: \$ 1850.00
