Access Compliance Report

Public Rights-of-Way

(Curb Ramps)

Intersection ID: 11764	Main Street: BEACON_ST	Cross Street: MECKLENBURG_AV	Location: NE
ADA ID: F96701C15EEF	Ramp Type: BlendTrans1	Initial Pass/Fail: Fail	Overall Compliance: No
Severity Score: 30			
Codes/Mitigation Info/Possible Solution		Field Measurements/Component Compliance

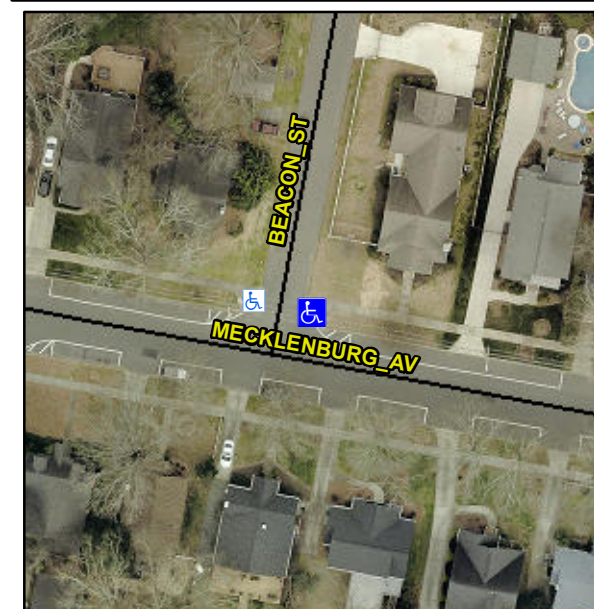
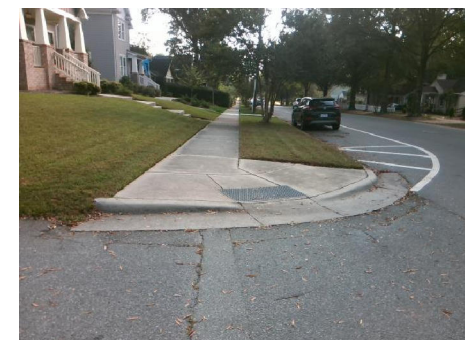
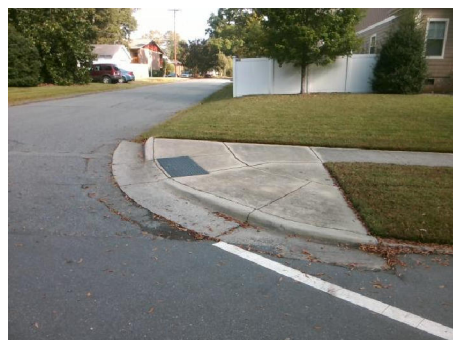
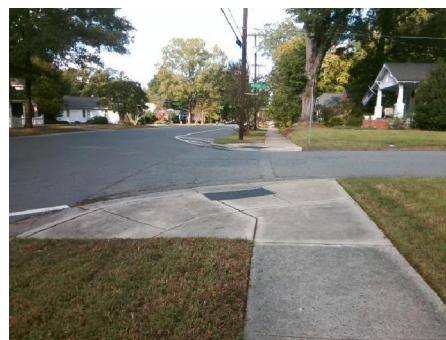
Not Found, R304.5.1, R304.5.3

Compliance	Description	Data	Compliance	Description	Data
N/A	Ramp Length (in)	58.5	Yes	BlendTrans Slope (%)	3.5
No	Ramp Width (in)	34.5	No	BlendTrans XSlope (%)	6.5
N/A	Flare Type LT	N/A	N/A	Flare Type RT	N/A
N/A	Flare Slope LT (%)	N/A	N/A	Flare Slope RT (%)	N/A
N/A	Flare Traversable LT?	N/A	N/A	Flare Traversable RT?	N/A
N/A	Landing Length (in)	N/A	N/A	DWS Provided?	N/A
N/A	Landing Width (in)	N/A	N/A	DWS Contrast?	N/A
N/A	Landing Slope (%)	N/A	N/A	DWS Length (in)	N/A
N/A	Landing X Slope (%)	N/A	N/A	DWS Full Width?	N/A
N/A	Landing Curb? (Y/N)	N/A	N/A	DWS Offset (in)	N/A
N/A	Shared Landing?	N/A			
N/A	Gutter Ponding?	N/A	N/A	Gutter Slope (%)	N/A
N/A	Gutter Lip Ht (in)	N/A	N/A	Gutter X Slope (%)	N/A
N/A	Painted X Walk1?	No	N/A	Painted X Walk2?	N/A
	X Walk 1 Direction	To W		X Walk 2 Direction	N/A
	X Walk 1 Width (in)	N/A		X Walk 2 Width (in)	N/A
	X Walk 1 Slope (%)	3.3		X Walk 2 Slope (%)	N/A
	X Walk 1 X Slope (%)	4.1		X Walk 2 X Slope (%)	N/A

N/A	Ramp inside XWalk1?	N/A	N/A	Ramp inside XWalk2?	N/A
	Road Slope (%)	4.1		Clear Space?	N/A
	Road X Slope (%)	3.3	N/A	Clear Space to XWalk (in)	N/A
N/A	Any Obstructions?	N/A	N/A	Storm Grate/Utility Hazard?	N/A
	Obstruction Type			Storm Grate/Utility Type	
		N/A			N/A
			Yes	Surface Condition? (G/P)	Good
			No	Curb Slope (%)	10.8

Possible Solutions:

Remove & Replace Curb Ramp With Two New Directional Ramps or Equivalent.
