Access Compliance Report

Public Rights-of-Way

(Curb Ramps)

Intersection ID: 17207	Main Street: CHILTON_PL	Cross Street: QUEENS_RD_EAST	Location: S
ADA ID: F978B7E9BD2F	Ramp Type: Directional1	Initial Pass/Fail: Fail	Overall Compliance: No
		Severity Score: 12.5

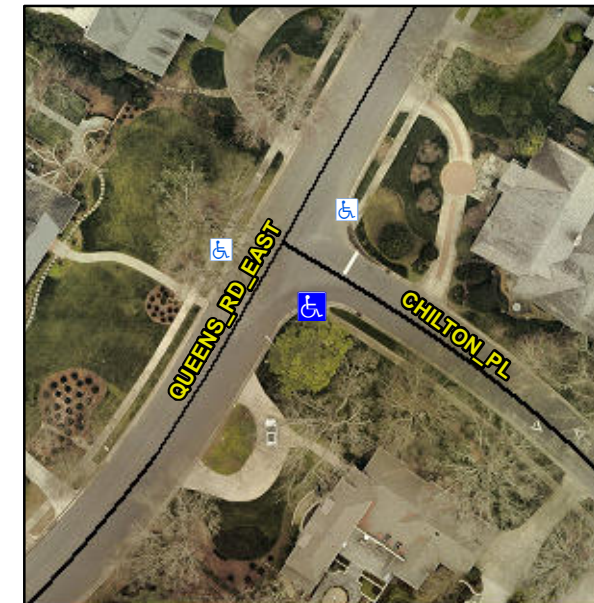
Compliance	Description	Data	Compliance	Description	Data
N/A	Ramp Length (in)	57.5	N/A	Grade Break?	N/A
Yes	Ramp Width (in)	53.0	N/A	Grade Break Slope (%)	0.0
No	Ramp Slope (%)	8.7	N/A	Grade Break XSlope (%)	0.0
Yes	Ramp XSlope (%)	1.5			
N/A	Flare Type LT	N/A	N/A	Flare Type RT	N/A
N/A	Flare Slope LT (%)	N/A	N/A	Flare Slope RT (%)	0.0
N/A	Flare Traversable LT?	N/A	N/A	Flare Traversable RT?	N/A
N/A	Landing Length (in)	0.0	N/A	DWS Provided?	N/A
N/A	Landing Width (in)	0.0	N/A	DWS Contrast?	N/A
N/A	Landing Slope (%)	0.0	N/A	DWS Length (in)	N/A
N/A	Landing X Slope (%)	0.0	N/A	DWS Full Width?	N/A
N/A	Landing Curb? (Y/N)	N/A	N/A	DWS Offset LT (in)	N/A
N/A	Shared Landing?	N/A	N/A	DWS Offset RT (in)	N/A
N/A	Gutter Ponding?	0.0	N/A	Gutter Slope (%)	N/A
N/A	Gutter Lip Ht (in)	0.0	N/A	Gutter X Slope (%)	N/A
N/A	Painted X Walk1?	No		Road Slope (%)	1.7
	X Walk 1 Direction	To W		Road X Slope (%)	7.4
	X Walk 1 Width (in)	N/A		Clear Space?	N/A

X Walk 1 Slope (%)	1.7	N/A	Clear Space to XWalk (in)	N/A
	X Walk 1 X Slope (%)	7.4	N/A	Storm Grate/Utility Hazard?	N/A
N/A	Ramp inside XWalk1?	N/A		Storm Grate/Utility Type	
N/A	Any Obstructions?	N/A			N/A
	Obstruction Type		Yes	Surface Condition? (G/P)	Good
			N/A	Curb Slope (%)	5.1

Possible Solutions:

Remove & Replace Entire Ramp.
