Access Compliance Report

Public Rights-of-Way

(Curb Ramps)

Intersection ID: 20281	Main Street: CEDAR_LN	Cross Street: PROVIDENCE_RD	Location: W
ADA ID: F98AF2E4D9FD	Ramp Type: Directional1	Initial Pass/Fail: Fail	Overall Compliance: No
			Severity Score: 13.75

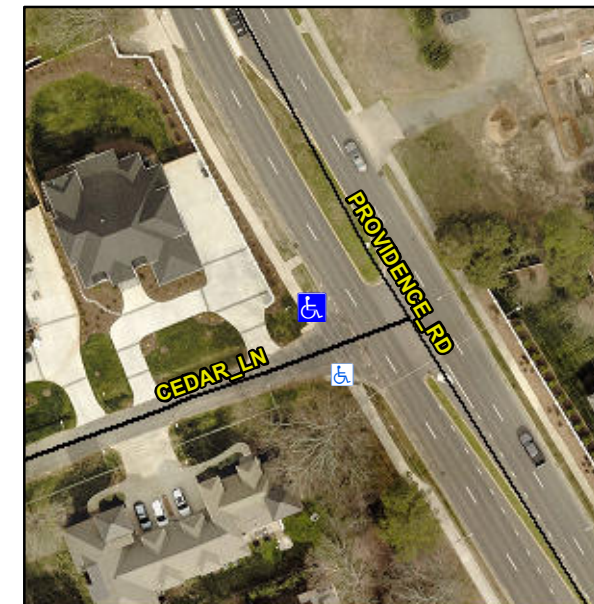
R304.2.2, R304.5.3

Compliance	Description	Data	Compliance	Description	Data
N/A	Ramp Length (in)	126.0	N/A	Grade Break?	N/A
Yes	Ramp Width (in)	71.0	N/A	Grade Break Slope (%)	0.0
No	Ramp Slope (%)	9.1	N/A	Grade Break XSlope (%)	0.0
No	Ramp XSlope (%)	2.5			
N/A	Flare Type LT	N/A	N/A	Flare Type RT	N/A
N/A	Flare Slope LT (%)	N/A	N/A	Flare Slope RT (%)	0.0
N/A	Flare Traversable LT?	N/A	N/A	Flare Traversable RT?	N/A
N/A	Landing Length (in)	0.0	N/A	DWS Provided?	N/A
N/A	Landing Width (in)	0.0	N/A	DWS Contrast?	N/A
N/A	Landing Slope (%)	0.0	N/A	DWS Length (in)	N/A
N/A	Landing X Slope (%)	0.0	N/A	DWS Full Width?	N/A
N/A	Landing Curb? (Y/N)	N/A	N/A	DWS Offset LT (in)	N/A
N/A	Shared Landing?	N/A	N/A	DWS Offset RT (in)	N/A
N/A	Gutter Ponding?	0.0	N/A	Gutter Slope (%)	N/A
N/A	Gutter Lip Ht (in)	0.0	N/A	Gutter X Slope (%)	N/A
N/A	Painted X Walk1?	No		Road Slope (%)	0.9
	X Walk 1 Direction	To SE		Road X Slope (%)	0.5
	X Walk 1 Width (in)	N/A		Clear Space?	N/A

X Walk 1 Slope (%)	0.9	N/A	Clear Space to XWalk (in)	N/A
	X Walk 1 X Slope (%)	0.5	N/A	Storm Grate/Utility Hazard?	N/A
N/A	Ramp inside XWalk1?	N/A		Storm Grate/Utility Type	
N/A	Any Obstructions?	N/A			N/A
	Obstruction Type		Yes	Surface Condition? (G/P)	Good
			N/A	Curb Slope (%)	7.8

Remove & Replace Entire Ramp.
