Access Compliance Report

Public Rights-of-Way

(Curb Ramps)

Intersection ID: 28727	Main Street: STEWARTS_CROSSING_DR	Cross Street: TRESHAM_CT	Location:	N
ADA ID: F9930FF10688	Ramp Type: Perp	Initial Pass/Fail: Fail	Overall Compliance: No	Severity Score: 22.5
Codes/Mitigation Info/Possible Solution		Field Measurements/Component Compliance

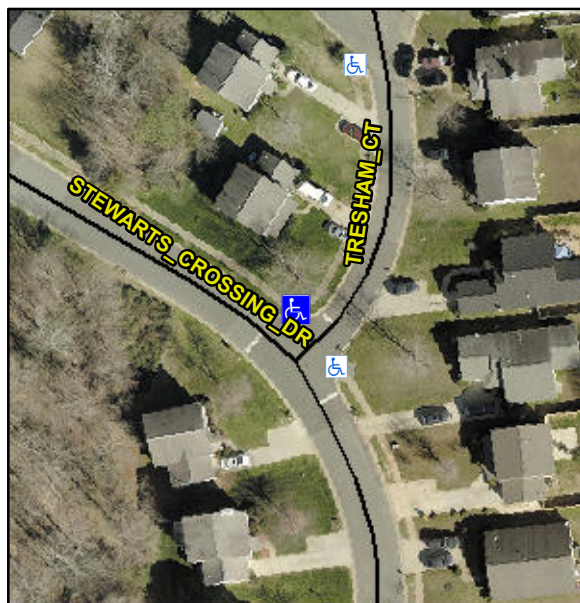
Compliance	Description	Data	Compliance	Description	Data
N/A	Ramp Length (in)	46.5	No	Ramp Slope (%)	9.5
No	Ramp Width (in)	47.0	No	Ramp XSlope (%)	3.3
N/A	Flare Type LT	N/A	N/A	Flare Type RT	N/A
N/A	Flare Slope LT (%)	N/A	N/A	Flare Slope RT (%)	N/A
N/A	Flare Traversable LT?	N/A	N/A	Flare Traversable RT?	N/A
N/A	Landing Length (in)	N/A	N/A	DWS Provided?	N/A
N/A	Landing Width (in)	N/A	N/A	DWS Contrast?	N/A
N/A	Landing Slope (%)	N/A	N/A	DWS Length (in)	N/A
N/A	Landing X Slope (%)	N/A	N/A	DWS Full Width?	N/A
N/A	Landing Curb? (Y/N)	N/A	N/A	DWS Offset (in)	N/A
N/A	Shared Landing?	N/A			
N/A	Gutter Ponding?	N/A	N/A	Gutter Slope (%)	N/A
N/A	Gutter Lip Ht (in)	N/A	N/A	Gutter X Slope (%)	N/A
N/A	Painted X Walk1?	No	N/A	Painted X Walk2?	N/A
	X Walk 1 Direction	To S		X Walk 2 Direction	N/A
N/A	X Walk 1 Width (in)	N/A	N/A	X Walk 2 Width (in)	N/A
	X Walk 1 Slope (%)	4.3		X Walk 2 Slope (%)	N/A
	X Walk 1 X Slope (%)	1.0		X Walk 2 X Slope (%)	N/A

N/A	Ramp inside XWalk1?	N/A	N/A	Ramp inside XWalk2?	N/A
	Road Slope (%)	N/A	N/A	Clear Space?	N/A
	Road X Slope (%)	N/A	N/A	Clear Space to XWalk (in)	N/A
N/A	Any Obstructions?	N/A	N/A	Storm Grate/Utility Hazard?	N/A
	Obstruction Type			Storm Grate/Utility Type	
		N/A			N/A
			Yes	Surface Condition? (G/P)	Good

Possible Solutions:

Remove & Replace Entire Ramp.
