Access Compliance Report

Public Rights-of-Way

(Curb Ramps)

Intersection ID: 14214	Main Street: E_PARK_AV	Cross Street: MYRTLE_AV	Location:	S
ADA ID: F9988DBBC65C	Ramp Type: Directional1	Initial Pass/Fail: Fail	Overall Compliance: No	Severity Score: 25

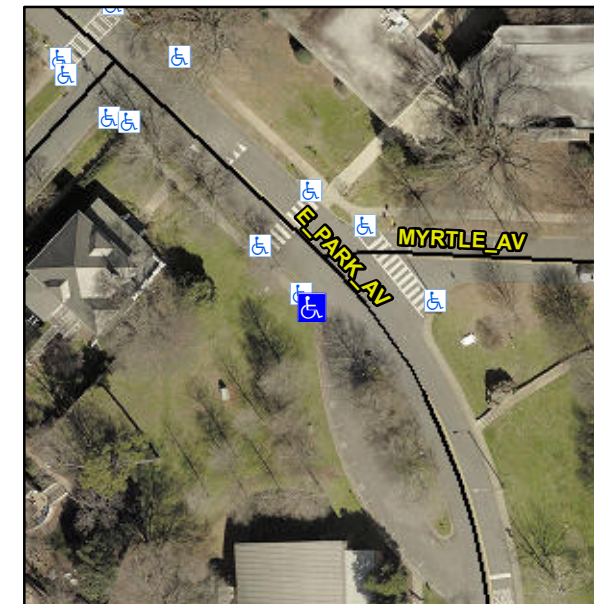
R304.2.2, R304.5.3

Compliance	Description	Data	Compliance	Description	Data
N/A	Ramp Length (in)	66.0	N/A	Grade Break?	N/A
Yes	Ramp Width (in)	66.0	N/A	Grade Break Slope (%)	0.0
No	Ramp Slope (%)	11.3	N/A	Grade Break XSlope (%)	0.0
No	Ramp XSlope (%)	5.9			
N/A	Flare Type LT	N/A	N/A	Flare Type RT	N/A
N/A	Flare Slope LT (%)	N/A	N/A	Flare Slope RT (%)	0.0
N/A	Flare Traversable LT?	N/A	N/A	Flare Traversable RT?	N/A
N/A	Landing Length (in)	0.0	N/A	DWS Provided?	N/A
N/A	Landing Width (in)	0.0	N/A	DWS Contrast?	N/A
N/A	Landing Slope (%)	0.0	N/A	DWS Length (in)	N/A
N/A	Landing X Slope (%)	0.0	N/A	DWS Full Width?	N/A
N/A	Landing Curb? (Y/N)	N/A	N/A	DWS Offset LT (in)	N/A
N/A	Shared Landing?	N/A	N/A	DWS Offset RT (in)	N/A
N/A	Gutter Ponding?	0.0	N/A	Gutter Slope (%)	N/A
N/A	Gutter Lip Ht (in)	2.0	N/A	Gutter X Slope (%)	N/A
N/A	Painted X Walk1?	No		Road Slope (%)	6.4
	X Walk 1 Direction	To E		Road X Slope (%)	1.9
	X Walk 1 Width (in)	N/A		Clear Space?	N/A

X Walk 1 Slope (%)	6.4	N/A	Clear Space to XWalk (in)	N/A
	X Walk 1 X Slope (%)	1.9	N/A	Storm Grate/Utility Hazard?	N/A
N/A	Ramp inside XWalk1?	N/A		Storm Grate/Utility Type	
N/A	Any Obstructions?	N/A			N/A
	Obstruction Type		Yes	Surface Condition? (G/P)	Good
			N/A	Curb Slope (%)	11.6

Remove & Replace Entire Ramp.
