Access Compliance Report

Public Rights-of-Way

(Curb Ramps)

Intersection ID: 10021759	Main Street: BRIARWICK_LN	Cross Street: BRIARWICK_LN	Location: NE
ADA ID: F9A21F9452F4	Ramp Type: Perp	Initial Pass/Fail: Fail	Overall Compliance: No
Severity Score: 12.5			
Codes/Mitigation Info/Possible Solution		Field Measurements/Component Compliance

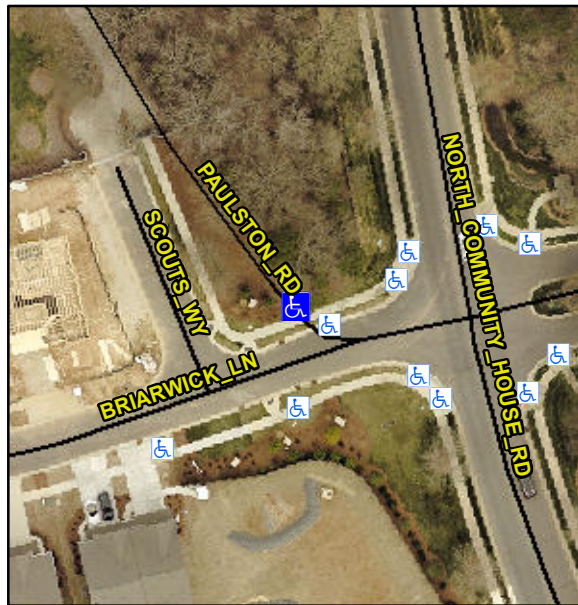
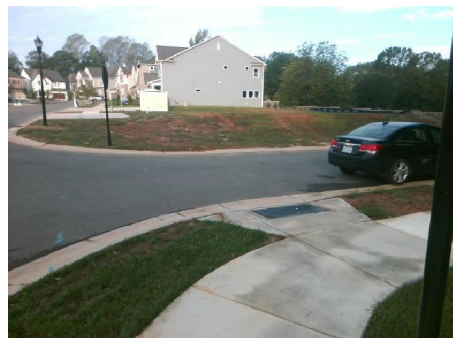
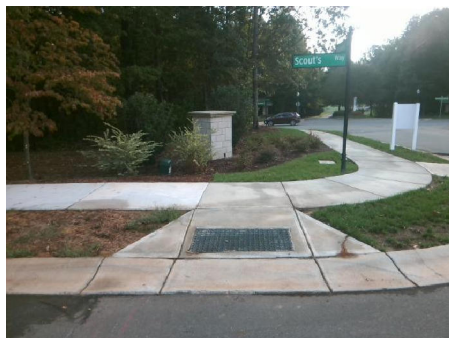
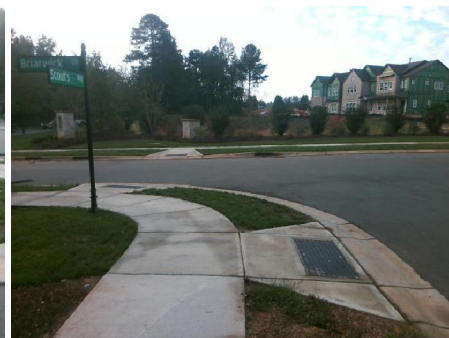
Compliance	Description	Data	Compliance	Description	Data
N/A	Ramp Length (in)	58.0	No	Ramp Slope (%)	8.8
Yes	Ramp Width (in)	57.5	Yes	Ramp XSlope (%)	1.3
N/A	Flare Type LT	N/A	N/A	Flare Type RT	N/A
N/A	Flare Slope LT (%)	N/A	N/A	Flare Slope RT (%)	N/A
N/A	Flare Traversable LT?	N/A	N/A	Flare Traversable RT?	N/A
N/A	Landing Length (in)	N/A	N/A	DWS Provided?	N/A
N/A	Landing Width (in)	N/A	N/A	DWS Contrast?	N/A
N/A	Landing Slope (%)	N/A	N/A	DWS Length (in)	N/A
N/A	Landing X Slope (%)	N/A	N/A	DWS Full Width?	N/A
N/A	Landing Curb? (Y/N)	N/A	N/A	DWS Offset (in)	N/A
N/A	Shared Landing?	N/A			
N/A	Gutter Ponding?	N/A	N/A	Gutter Slope (%)	N/A
N/A	Gutter Lip Ht (in)	1.0	N/A	Gutter X Slope (%)	N/A
N/A	Painted X Walk1?	No	N/A	Painted X Walk2?	N/A
	X Walk 1 Direction	To W		X Walk 2 Direction	N/A
N/A	X Walk 1 Width (in)	N/A	N/A	X Walk 2 Width (in)	N/A
	X Walk 1 Slope (%)	1.6		X Walk 2 Slope (%)	N/A
	X Walk 1 X Slope (%)	1.3		X Walk 2 X Slope (%)	N/A

N/A	Ramp inside XWalk1?	N/A	N/A	Ramp inside XWalk2?	N/A
	Road Slope (%)	N/A	N/A	Clear Space?	N/A
	Road X Slope (%)	N/A	N/A	Clear Space to XWalk (in)	N/A
N/A	Any Obstructions?	N/A	N/A	Storm Grate/Utility Hazard?	N/A
	Obstruction Type			Storm Grate/Utility Type	
		N/A			N/A
		Yes		Surface Condition? (G/P)	Good

Remove & Replace Entire Ramp.

R304.2.2

\$ 1850.00
