# Access Compliance Report

## Public Rights-of-Way

### (Curb Ramps)

Intersection ID: 3919	Main Street: MOUNTAIN_PARK_DR	Cross Street: MT_ISLE_HARBOR_DR	Location: SE
ADA ID: F9A76233BFBD	Ramp Type: Perp	Initial Pass/Fail: Fail	Overall Compliance: No
Severity Score: 12.5			
Codes/Mitigation Info/Possible Solution		Field Measurements/Component Compliance

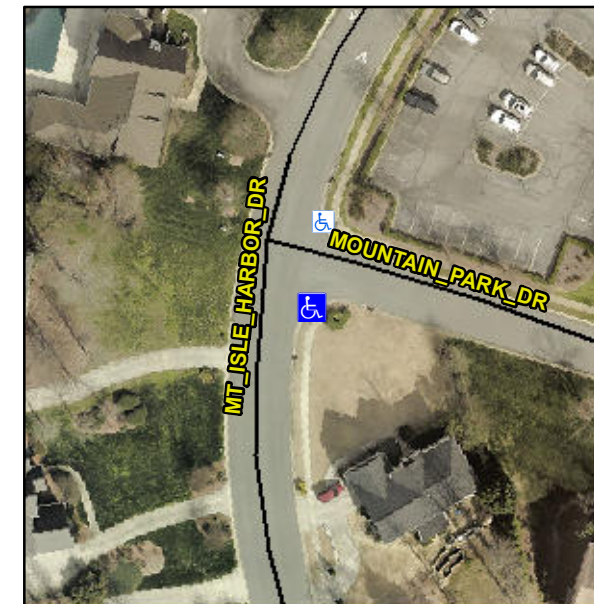
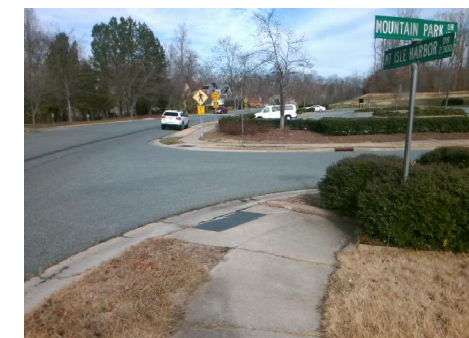
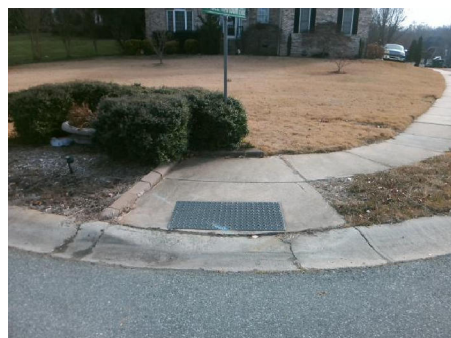
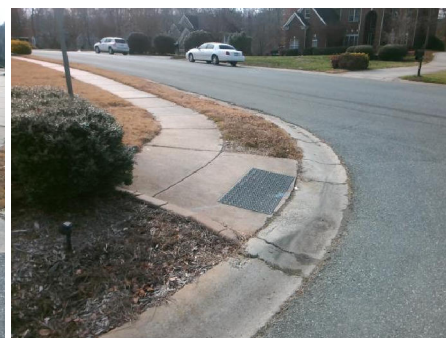
**Not Found, R304.2.2**

Compliance	Description	Data	Compliance	Description	Data
N/A	Ramp Length (in)	52.0	No	Ramp Slope (%)	9.9
Yes	Ramp Width (in)	48.0	Yes	Ramp XSlope (%)	1.9
N/A	Flare Type LT	N/A	N/A	Flare Type RT	N/A
N/A	Flare Slope LT (%)	N/A	N/A	Flare Slope RT (%)	N/A
N/A	Flare Traversable LT?	N/A	N/A	Flare Traversable RT?	N/A
N/A	Landing Length (in)	N/A	N/A	DWS Provided?	N/A
N/A	Landing Width (in)	N/A	N/A	DWS Contrast?	N/A
N/A	Landing Slope (%)	N/A	N/A	DWS Length (in)	N/A
N/A	Landing X Slope (%)	N/A	N/A	DWS Full Width?	N/A
N/A	Landing Curb? (Y/N)	N/A	N/A	DWS Offset (in)	N/A
N/A	Shared Landing?	N/A			
N/A	Gutter Ponding?	N/A	N/A	Gutter Slope (%)	N/A
N/A	Gutter Lip Ht (in)	2.0	N/A	Gutter X Slope (%)	N/A
N/A	Painted X Walk1?	No	N/A	Painted X Walk2?	N/A
	X Walk 1 Direction	To N		X Walk 2 Direction	N/A
N/A	X Walk 1 Width (in)	N/A	N/A	X Walk 2 Width (in)	N/A
	X Walk 1 Slope (%)	1.9		X Walk 2 Slope (%)	N/A
	X Walk 1 X Slope (%)	1.1		X Walk 2 X Slope (%)	N/A

N/A	Ramp inside XWalk1?	N/A	N/A	Ramp inside XWalk2?	N/A
	Road Slope (%)	N/A	N/A	Clear Space?	N/A
	Road X Slope (%)	N/A	N/A	Clear Space to XWalk (in)	N/A
N/A	Any Obstructions?	N/A	N/A	Storm Grate/Utility Hazard?	N/A
	Obstruction Type			Storm Grate/Utility Type	
		N/A			N/A
			Yes	Surface Condition? (G/P)	Good

**Remove & Replace Entire Ramp.**
