# Access Compliance Report

## Public Rights-of-Way

### (Curb Ramps)

| Intersection ID: 53191 | Main Street: JOHNSTON_OEHLER_PRIVATE_DR | Cross Street: JOHNSTON_OEHLER_RD | Location: SW |

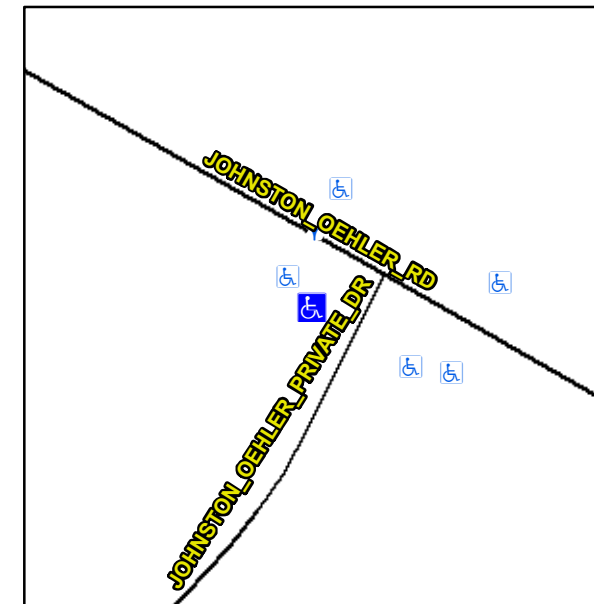
**Not Found, R304.5.2**

| Compliance | Description | Data | Compliance | Description | Data |
|---|---|---|---|---|---|
| N/A | Ramp Length (in) | 96.0 | No | Grade Break? | No |
| Yes | Ramp Width (in) | 69.0 | N/A | Grade Break Slope (%) | 5.0 |
| Yes | Ramp Slope (%) | 6.5 | N/A | Grade Break XSlope (%) | 2.1 |
| Yes | Landing Length (in) | 73.0 | Yes | DWS Provided? | Yes |
| Yes | Landing Slope (%) | 1.9 | Yes | DWS Length (in) | 24.0 |

**Remove & Replace Entire Ramp.**

Total Cost: \$ 1600.00
