Access Compliance Report

Public Rights-of-Way

(Curb Ramps)

Intersection ID: N/A	Main Street: E MARTIN LUTHER KING JR BLVD	Cross Street: S BREVARD ST	Location: S
ADA ID: F9B259E1DA6E	Ramp Type: BlendTrans1	Initial Pass/Fail: Pass	Overall Compliance: No
			Severity Score: 0

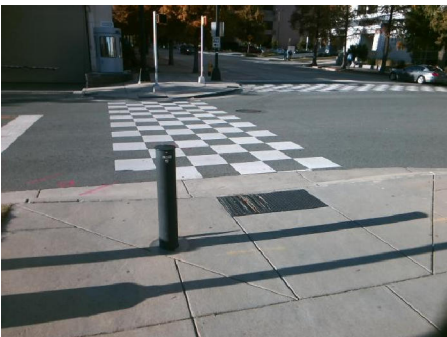
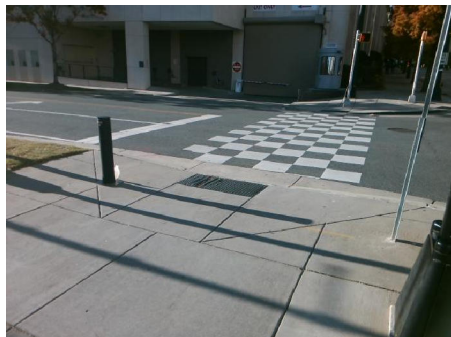
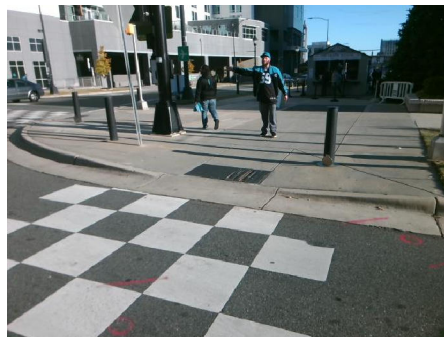
DAMAGED DWS

Yes	Ramp inside XWalk1?	Yes	N/A	Ramp inside XWalk2?	N/A
	Road Slope (%)	0.7		Clear Space?	Yes
	Road X Slope (%)	0.7	N/A	Clear Space to XWalk (in)	N/A
Yes	Any Obstructions?	No	Yes	Storm Grate/Utility Hazard?	No
	Obstruction Type			Storm Grate/Utility Type	
		N/A			N/A
			Yes	Surface Condition? (G/P)	Good
			No	Curb Slope (%)	8.1

Possible Solutions:

Remove & Replace Curb Slope and Extend Ramp.
