Access Compliance Report

Public Rights-of-Way

(Curb Ramps)

Intersection ID: 50867	Main Street: REAMES_RD	Cross Street: BROOKLINE_RIDGE_DR	Location: S
ADA ID: F9BCB7F9E8E3	Ramp Type: Perp	Initial Pass/Fail: Fail	Overall Compliance: No
Severity Score: 8.75			
Codes/Mitigation Info/Possible Solution		Field Measurements/Component Compliance

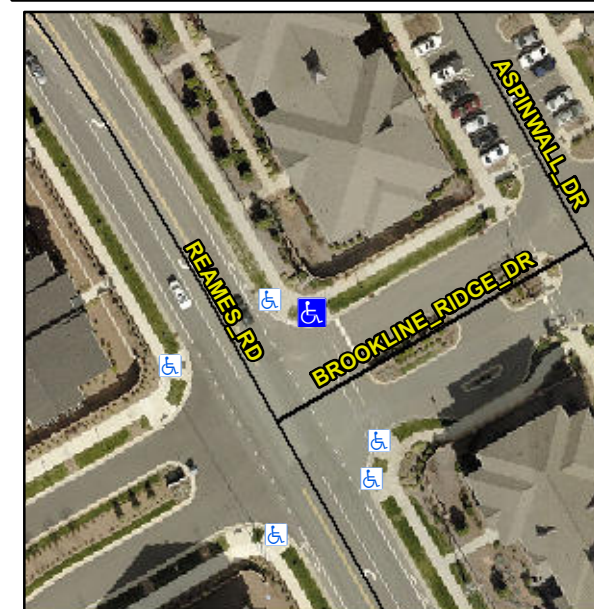
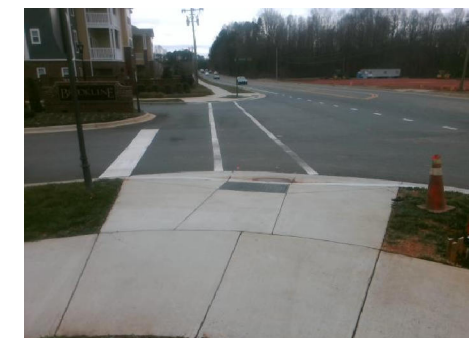
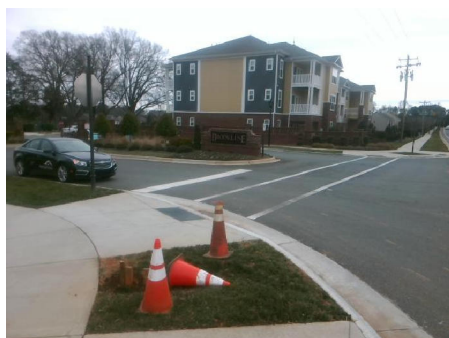
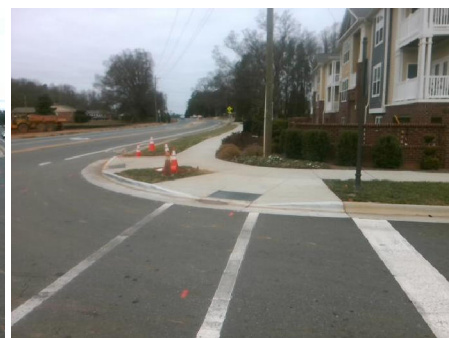
Not Found, R304.5.1

Compliance	Description	Data	Compliance	Description	Data
N/A	Ramp Length (in)	96.5	Yes	Ramp Slope (%)	7.3
No	Ramp Width (in)	47.0	Yes	Ramp XSlope (%)	0.7
N/A	Flare Type LT	N/A	N/A	Flare Type RT	N/A
N/A	Flare Slope LT (%)	N/A	N/A	Flare Slope RT (%)	N/A
N/A	Flare Traversable LT?	N/A	N/A	Flare Traversable RT?	N/A
N/A	Landing Length (in)	N/A	N/A	DWS Provided?	N/A
N/A	Landing Width (in)	N/A	N/A	DWS Contrast?	N/A
N/A	Landing Slope (%)	N/A	N/A	DWS Length (in)	N/A
N/A	Landing X Slope (%)	N/A	N/A	DWS Full Width?	N/A
N/A	Landing Curb? (Y/N)	N/A	N/A	DWS Offset (in)	N/A
N/A	Shared Landing?	N/A			
N/A	Gutter Ponding?	N/A	N/A	Gutter Slope (%)	N/A
N/A	Gutter Lip Ht (in)	N/A	N/A	Gutter X Slope (%)	N/A
N/A	Painted X Walk1?	Yes	N/A	Painted X Walk2?	N/A
	X Walk 1 Direction	To S		X Walk 2 Direction	N/A
N/A	X Walk 1 Width (in)	60.0	N/A	X Walk 2 Width (in)	N/A
	X Walk 1 Slope (%)	1.0		X Walk 2 Slope (%)	N/A
	X Walk 1 X Slope (%)	0.3		X Walk 2 X Slope (%)	N/A

N/A	Ramp inside XWalk1?	Yes	N/A	Ramp inside XWalk2?	N/A
	Road Slope (%)	N/A	N/A	Clear Space?	N/A
	Road X Slope (%)	N/A	N/A	Clear Space to XWalk (in)	N/A
N/A	Any Obstructions?	N/A	N/A	Storm Grate/Utility Hazard?	N/A
	Obstruction Type			Storm Grate/Utility Type	
		N/A			N/A
		Yes		Surface Condition? (G/P)	Good

Possible Solutions:

Remove & Replace Entire Ramp.

Total Cost: \$ 1850.00
