Access Compliance Report

Public Rights-of-Way

(Curb Ramps)

Intersection ID: 24850	Main Street: BOURNEWOOD_LN	Cross Street: TRUSCOTT_RD	Location:	N
ADA ID: F9BF1BB3CA3F	Ramp Type: PerpDiag	Initial Pass/Fail: Fail	Overall Compliance: No	Severity Score: 8.75
Codes/Mitigation Info/Possible Solution		Field Measurements/Component Compliance

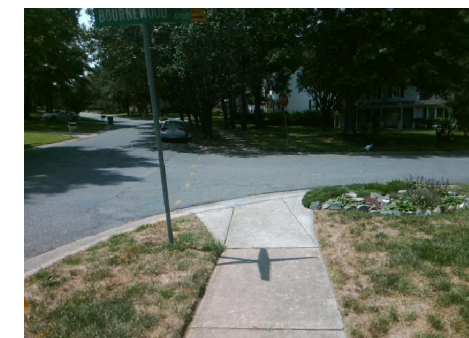
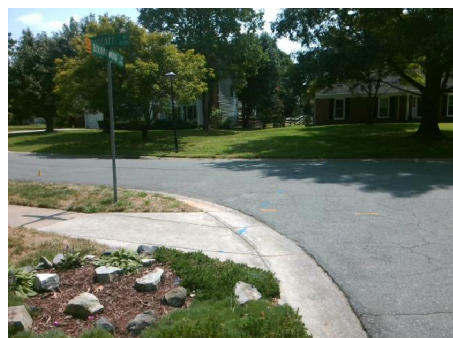
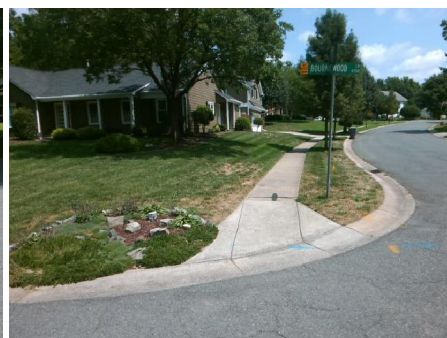
Compliance	Description	Data	Compliance	Description	Data
N/A	Ramp Length (in)	101.0	Yes	Ramp Slope (%)	6.1
No	Ramp Width (in)	41.5	Yes	Ramp XSlope (%)	0.6
N/A	Flare Type LT	N/A	N/A	Flare Type RT	N/A
N/A	Flare Slope LT (%)	N/A	N/A	Flare Slope RT (%)	N/A
N/A	Flare Traversable LT?	N/A	N/A	Flare Traversable RT?	N/A
N/A	Landing Length (in)	N/A	N/A	DWS Provided?	N/A
N/A	Landing Width (in)	N/A	N/A	DWS Contrast?	N/A
N/A	Landing Slope (%)	N/A	N/A	DWS Length (in)	N/A
N/A	Landing X Slope (%)	N/A	N/A	DWS Full Width?	N/A
N/A	Landing Curb? (Y/N)	N/A	N/A	DWS Offset (in)	N/A
N/A	Shared Landing?	N/A			
N/A	Gutter Ponding?	N/A	N/A	Gutter Slope (%)	N/A
N/A	Gutter Lip Ht (in)	N/A	N/A	Gutter X Slope (%)	N/A
N/A	Painted X Walk1?	No	N/A	Painted X Walk2?	No
	X Walk 1 Direction	To SW		X Walk 2 Direction	To E
N/A	X Walk 1 Width (in)	N/A	N/A	X Walk 2 Width (in)	N/A
	X Walk 1 Slope (%)	4.1		X Walk 2 Slope (%)	3.6
	X Walk 1 X Slope (%)	2.6		X Walk 2 X Slope (%)	1.8

N/A	Ramp inside XWalk1?	N/A	N/A	Ramp inside XWalk2?	N/A
	Road Slope (%)	0.7	N/A	Clear Space?	N/A
	Road X Slope (%)	3.9	N/A	Clear Space to XWalk (in)	N/A
N/A	Any Obstructions?	N/A	N/A	Storm Grate/Utility Hazard?	N/A
	Obstruction Type			Storm Grate/Utility Type	
		N/A			N/A
			Yes	Surface Condition? (G/P)	Good

Possible Solutions:

Remove & Replace Curb Ramp With Two New Directional Ramps or Equivalent.

Not Found, R304.5.1
