# Access Compliance Report

## Public Rights-of-Way

### (Curb Ramps)

Intersection ID: 6515	Main Street: AMY_DR	Cross Street: STARLING_CT	Location: N
ADA ID: F9D17E881548	Ramp Type: Perp	Initial Pass/Fail: Fail	Overall Compliance: No
Severity Score: 13.75			
Codes/Mitigation Info/Possible Solution		Field Measurements/Component Compliance

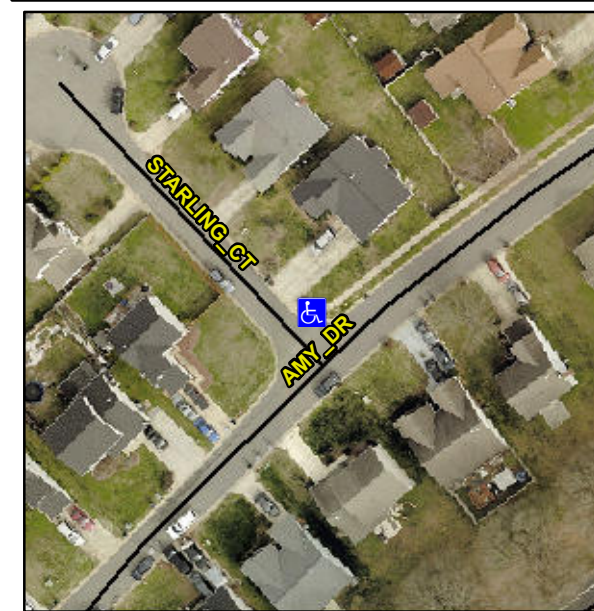
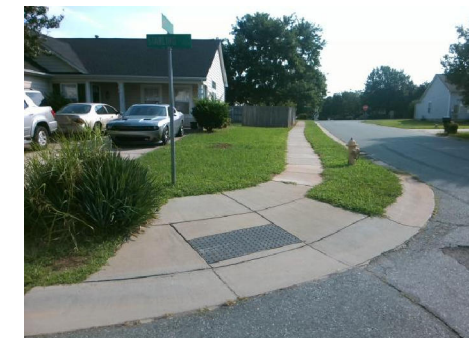
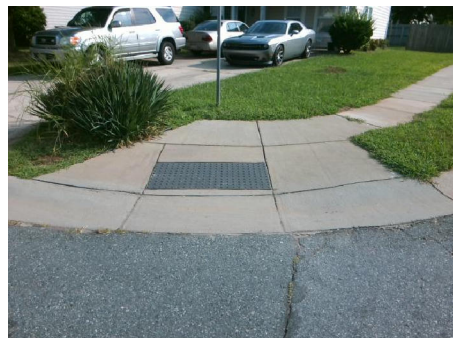
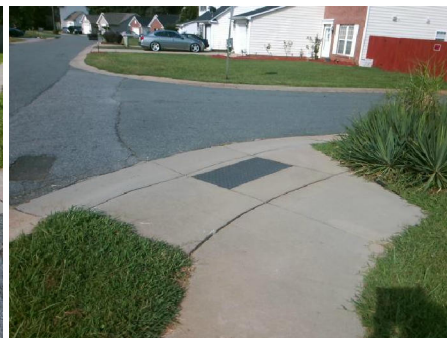
Compliance	Description	Data	Compliance	Description	Data
N/A	Ramp Length (in)	47.5	No	Ramp Slope (%)	8.5
Yes	Ramp Width (in)	48.0	No	Ramp XSlope (%)	2.6
N/A	Flare Type LT	N/A	N/A	Flare Type RT	N/A
N/A	Flare Slope LT (%)	N/A	N/A	Flare Slope RT (%)	N/A
N/A	Flare Traversable LT?	N/A	N/A	Flare Traversable RT?	N/A
N/A	Landing Length (in)	N/A	N/A	DWS Provided?	N/A
N/A	Landing Width (in)	N/A	N/A	DWS Contrast?	N/A
N/A	Landing Slope (%)	N/A	N/A	DWS Length (in)	N/A
N/A	Landing X Slope (%)	N/A	N/A	DWS Full Width?	N/A
N/A	Landing Curb? (Y/N)	N/A	N/A	DWS Offset (in)	N/A
N/A	Shared Landing?	N/A			
N/A	Gutter Ponding?	N/A	N/A	Gutter Slope (%)	N/A
N/A	Gutter Lip Ht (in)	N/A	N/A	Gutter X Slope (%)	N/A
N/A	Painted X Walk1?	No	N/A	Painted X Walk2?	N/A
	X Walk 1 Direction	To SW		X Walk 2 Direction	N/A
N/A	X Walk 1 Width (in)	N/A	N/A	X Walk 2 Width (in)	N/A
	X Walk 1 Slope (%)	1.9		X Walk 2 Slope (%)	N/A
	X Walk 1 X Slope (%)	0.3		X Walk 2 X Slope (%)	N/A

N/A	Ramp inside XWalk1?	N/A	N/A	Ramp inside XWalk2?	N/A
	Road Slope (%)	0.3	N/A	Clear Space?	N/A
	Road X Slope (%)	1.9	N/A	Clear Space to XWalk (in)	N/A
N/A	Any Obstructions?	N/A	N/A	Storm Grate/Utility Hazard?	N/A
	Obstruction Type			Storm Grate/Utility Type	
		N/A			N/A
			Yes	Surface Condition? (G/P)	Good

**Remove & Replace Entire Ramp.**

**R304.2.2, R304.5.3**

**\$ 1850.00**
