Access Compliance Report

Public Rights-of-Way

(Curb Ramps)

Intersection ID: N/A	Main Street: AMAY_JAMES_AV	Cross Street: CARONIA_ST	Location: NW
ADA ID: F9D6DE116ECA	Ramp Type: Perp	Initial Pass/Fail: Fail	Overall Compliance: No
Severity Score: 26.25			
Codes/Mitigation Info/Possible Solution		Field Measurements/Component Compliance

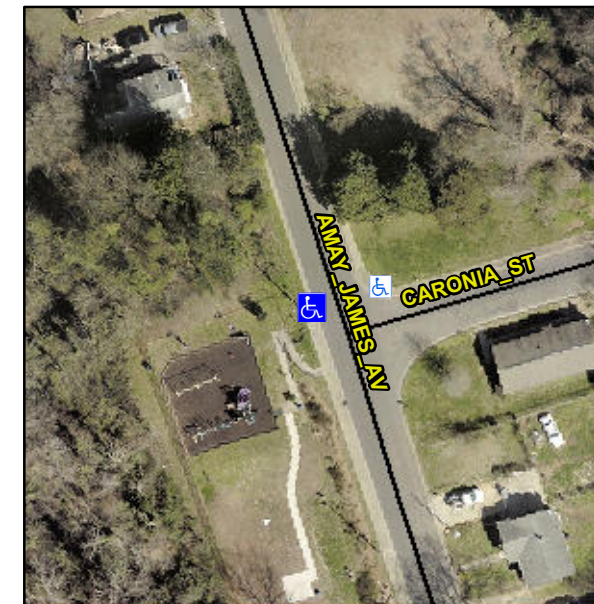
Not Found, R304.2.2

Compliance	Description	Data	Compliance	Description	Data
N/A	Ramp Length (in)	48.0	No	Ramp Slope (%)	12.0
Yes	Ramp Width (in)	54.0	Yes	Ramp XSlope (%)	3.6
N/A	Flare Type LT	N/A	N/A	Flare Type RT	N/A
N/A	Flare Slope LT (%)	N/A	N/A	Flare Slope RT (%)	N/A
N/A	Flare Traversable LT?	N/A	N/A	Flare Traversable RT?	N/A
N/A	Landing Length (in)	N/A	N/A	DWS Provided?	N/A
N/A	Landing Width (in)	N/A	N/A	DWS Contrast?	N/A
N/A	Landing Slope (%)	N/A	N/A	DWS Length (in)	N/A
N/A	Landing X Slope (%)	N/A	N/A	DWS Full Width?	N/A
N/A	Landing Curb? (Y/N)	N/A	N/A	DWS Offset (in)	N/A
N/A	Shared Landing?	N/A			
N/A	Gutter Ponding?	N/A	N/A	Gutter Slope (%)	N/A
N/A	Gutter Lip Ht (in)	N/A	N/A	Gutter X Slope (%)	N/A
N/A	Painted X Walk1?	No	N/A	Painted X Walk2?	N/A
	X Walk 1 Direction	To E		X Walk 2 Direction	N/A
N/A	X Walk 1 Width (in)	N/A	N/A	X Walk 2 Width (in)	N/A
	X Walk 1 Slope (%)	2.0		X Walk 2 Slope (%)	N/A
	X Walk 1 X Slope (%)	4.9		X Walk 2 X Slope (%)	N/A

N/A	Ramp inside XWalk1?	N/A	N/A	Ramp inside XWalk2?	N/A
	Road Slope (%)	N/A	N/A	Clear Space?	N/A
	Road X Slope (%)	N/A	N/A	Clear Space to XWalk (in)	N/A
N/A	Any Obstructions?	N/A	N/A	Storm Grate/Utility Hazard?	N/A
	Obstruction Type			Storm Grate/Utility Type	
		N/A			N/A
			Yes	Surface Condition? (G/P)	Good

Remove & Replace Entire Ramp.

Total Cost: \$ 1850.00
