Access Compliance Report Public Rights-of-Way (Curb Ramps)

Intersection ID: 50476 Main Street: BOW RD **Cross Street: KINGS RIDGE DR** Location: **ADA ID: F9EE0BB58311** Ramp Type: PerpDiag Initial Pass/Fail: Fail **Overall Compliance: No** Severity Score: 21.25

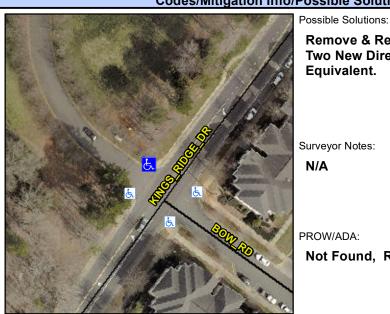
Not Found, R304.5.1, R304.5.3

Comp	liance Description	Data	Comp	liance	Description	Data
N/A	Ramp Length (in)	58.5	Yes	Ramp	Slope (%)	7.9
No	Ramp Width (in)	44.5	No	Ramp	XSlope (%)	5.5
N/A	Flare Type LT	N/A	N/A	Flare	Type RT	N/A
N/A	Flare Slope LT (%)	N/A	N/A	Flare	Slope RT (%)	N/A
N/A	Flare Traversable LT?	N/A	N/A	Flare	Traversable RT?	N/A
N/A	Landing Length (in)	N/A	N/A	DWS	Provided?	N/A
N/A	Landing Width (in)	N/A	N/A	DWS	Contrast?	N/A
N/A	Landing Slope (%)	N/A	N/A	DWS	Length (in)	N/A
N/A	Landing X Slope (%)	N/A	N/A	DWS	Full Width?	N/A
N/A	Landing Curb? (Y/N)	N/A	N/A	DWS	Offset (in)	N/A
N/A	Shared Landing?	N/A				
N/A	Gutter Ponding?	N/A	N/A	Gutte	Slope (%)	N/A
N/A	Gutter Lip Ht (in)	N/A	N/A	Gutte	X Slope (%)	N/A
N/A	Painted X Walk1?	No	N/A	Painte	ed X Walk2?	No
	X Walk 1 Direction	To SW		X Wal	k 2 Direction	To SE
N/A	X Walk 1 Width (in)	N/A	N/A	X Wal	k 2 Width (in)	N/A
	X Walk 1 Slope (%)	2.4		X Wal	k 2 Slope (%)	9.5
	X Walk 1 X Slope (%)	7.1		X Wal	k 2 X Slope (%)	0.5

N/A	Ramp inside XWalk1?	N/A	N/A	Ramp	inside XWalk2?	N/A
	Road Slope (%)	4.9	N/A	Clear	Space?	N/A
	Road X Slope (%)	2.6	N/A	Clear	Space to XWalk (in)	N/A
N/A	Any Obstructions?	N/A	N/A	Storm	Grate/Utility Hazard?	N/A
	Obstruction Type		l	Storm	Grate/Utility Type	
		N/A				N/A

Street 1 Name Stop Condition-Street 2 Street 2 Name Stop Condition-Street 1 Remove & Replace Curb Ramp With Two New Directional Ramps or Equivalent.
