# Access Compliance Report

## Public Rights-of-Way

### (Curb Ramps)

Intersection ID: 14111	Main Street: CENTRAL_AV	Cross Street: LANSDALE_DR	Location: SW
ADA ID: F9F0E3928496	Ramp Type: Perp	Initial Pass/Fail: Fail	Overall Compliance: No
			Severity Score: 48.75

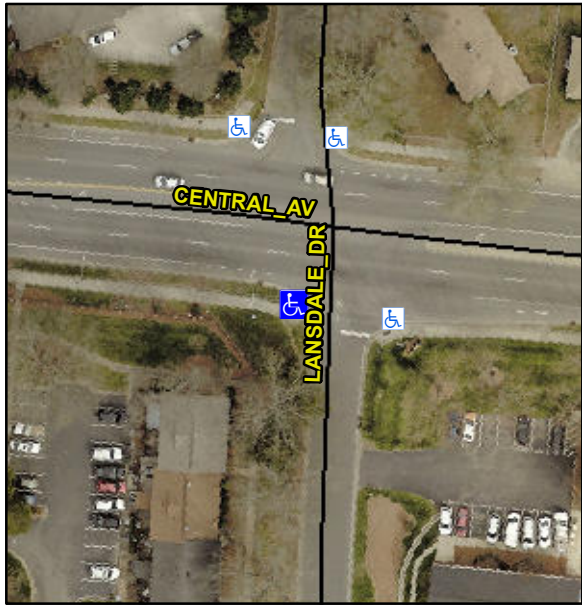
Possible Solutions:		Compliance	Description	Data	Compliance	Description	Data
	Remove & Replace Entire Ramp.		N/A	Ramp Length (in)	77.5	No	Ramp Slope (%)	10.6
			No	Ramp Width (in)	31.0	No	Ramp XSlope (%)	4.1
			N/A	Flare Type LT	N/A	N/A	Flare Type RT	N/A
			N/A	Flare Slope LT (%)	N/A	N/A	Flare Slope RT (%)	N/A
			N/A	Flare Traversable LT?	N/A	N/A	Flare Traversable RT?	N/A
			N/A	Landing Length (in)	N/A	N/A	DWS Provided?	N/A
			N/A	Landing Width (in)	N/A	N/A	DWS Contrast?	N/A
			N/A	Landing Slope (%)	N/A	N/A	DWS Length (in)	N/A
			N/A	Landing X Slope (%)	N/A	N/A	DWS Full Width?	N/A
Surveyor Notes:	N/A		N/A	Landing Curb? (Y/N)	N/A	N/A	DWS Offset (in)	N/A
			N/A	Shared Landing?	N/A			
	PROW/ADA:		N/A	Gutter Ponding?	N/A	N/A	Gutter Slope (%)	N/A
	Not Found, R304.5.1, R304.2.2, R304.5.3		N/A	Gutter Lip Ht (in)	N/A	N/A	Gutter X Slope (%)	N/A
